Ferry Buildings

Gurley & Nicholls

Correspondence from
Nov 1979

FERRY BUILDINGS - REQUEST BY CONSULTANTS
FOR PERMISSION TO PRESENT A PAPER

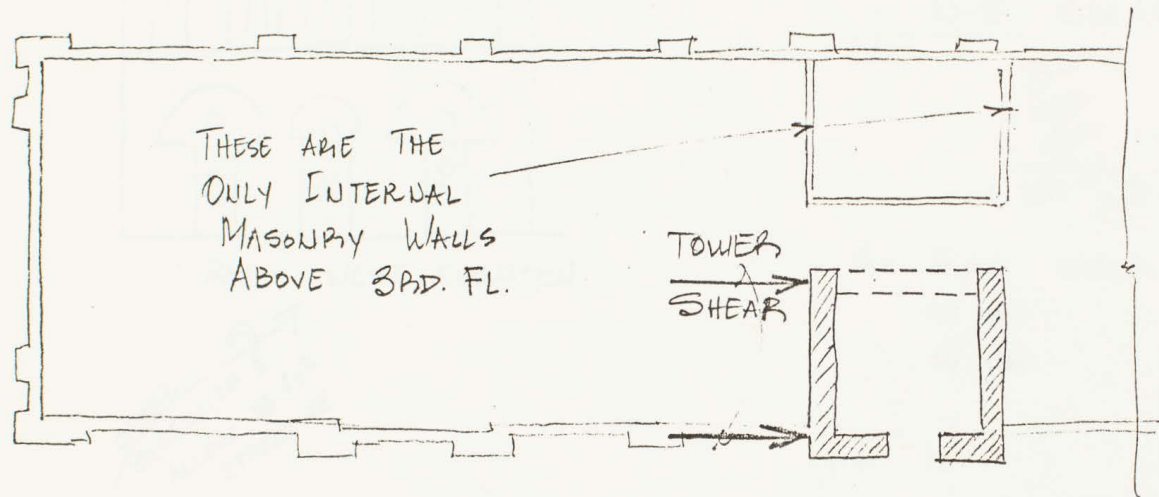
TOWER TORSION PROBLEM.

TOWER NORTH WALL ONLY
EXISTS ABOVE RL 74.2

ELF ② PROBABLY CONSERVATIVE

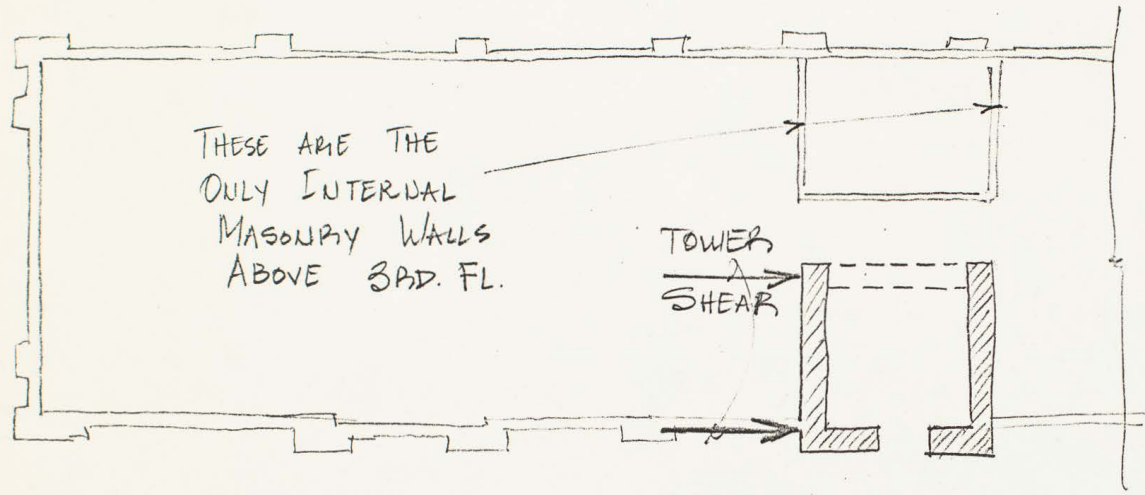
FERRY BUILDING.
TOWER TORSION PROBLEM.

THESE ARE THE ONLY INTERNAL MASONRY WALLS ABOVE 3RD. FL.

ELF ② PROBABLY CONSERVATIVE !!
