1000 Manukau Harb.
General.

Manukau Harbour gen.

incl Survey of Harbour Entrance
- Wairopa channel.

REPORT OF SURVEY - PURAKAU CHANNEL

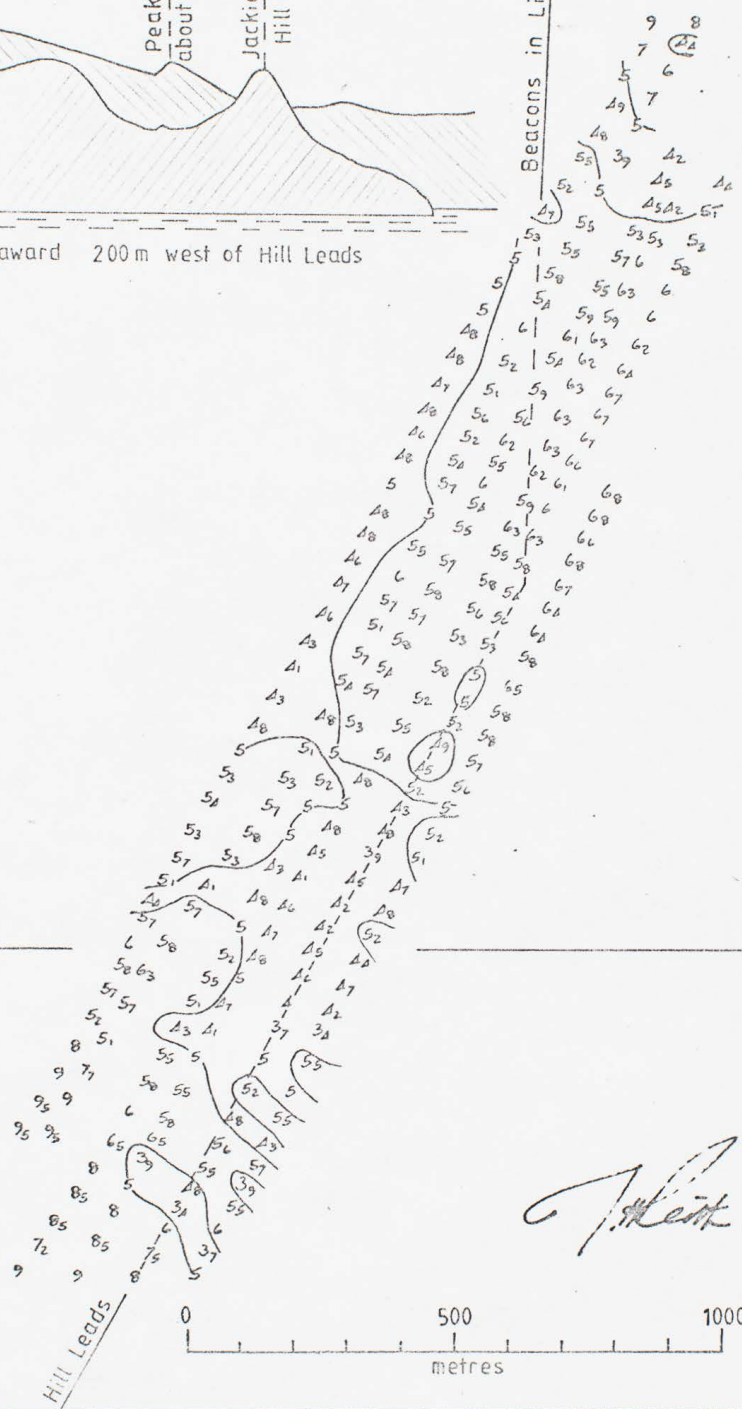
Manukau Harbour Entrance-South Channel
 Surveyed 23 Sept 1982
 Soundings in metres and decimetres below C.D.

A re-survey of the South Channel was carried out in very good sea conditions with negligible swell at half flood on 23 September 1982.

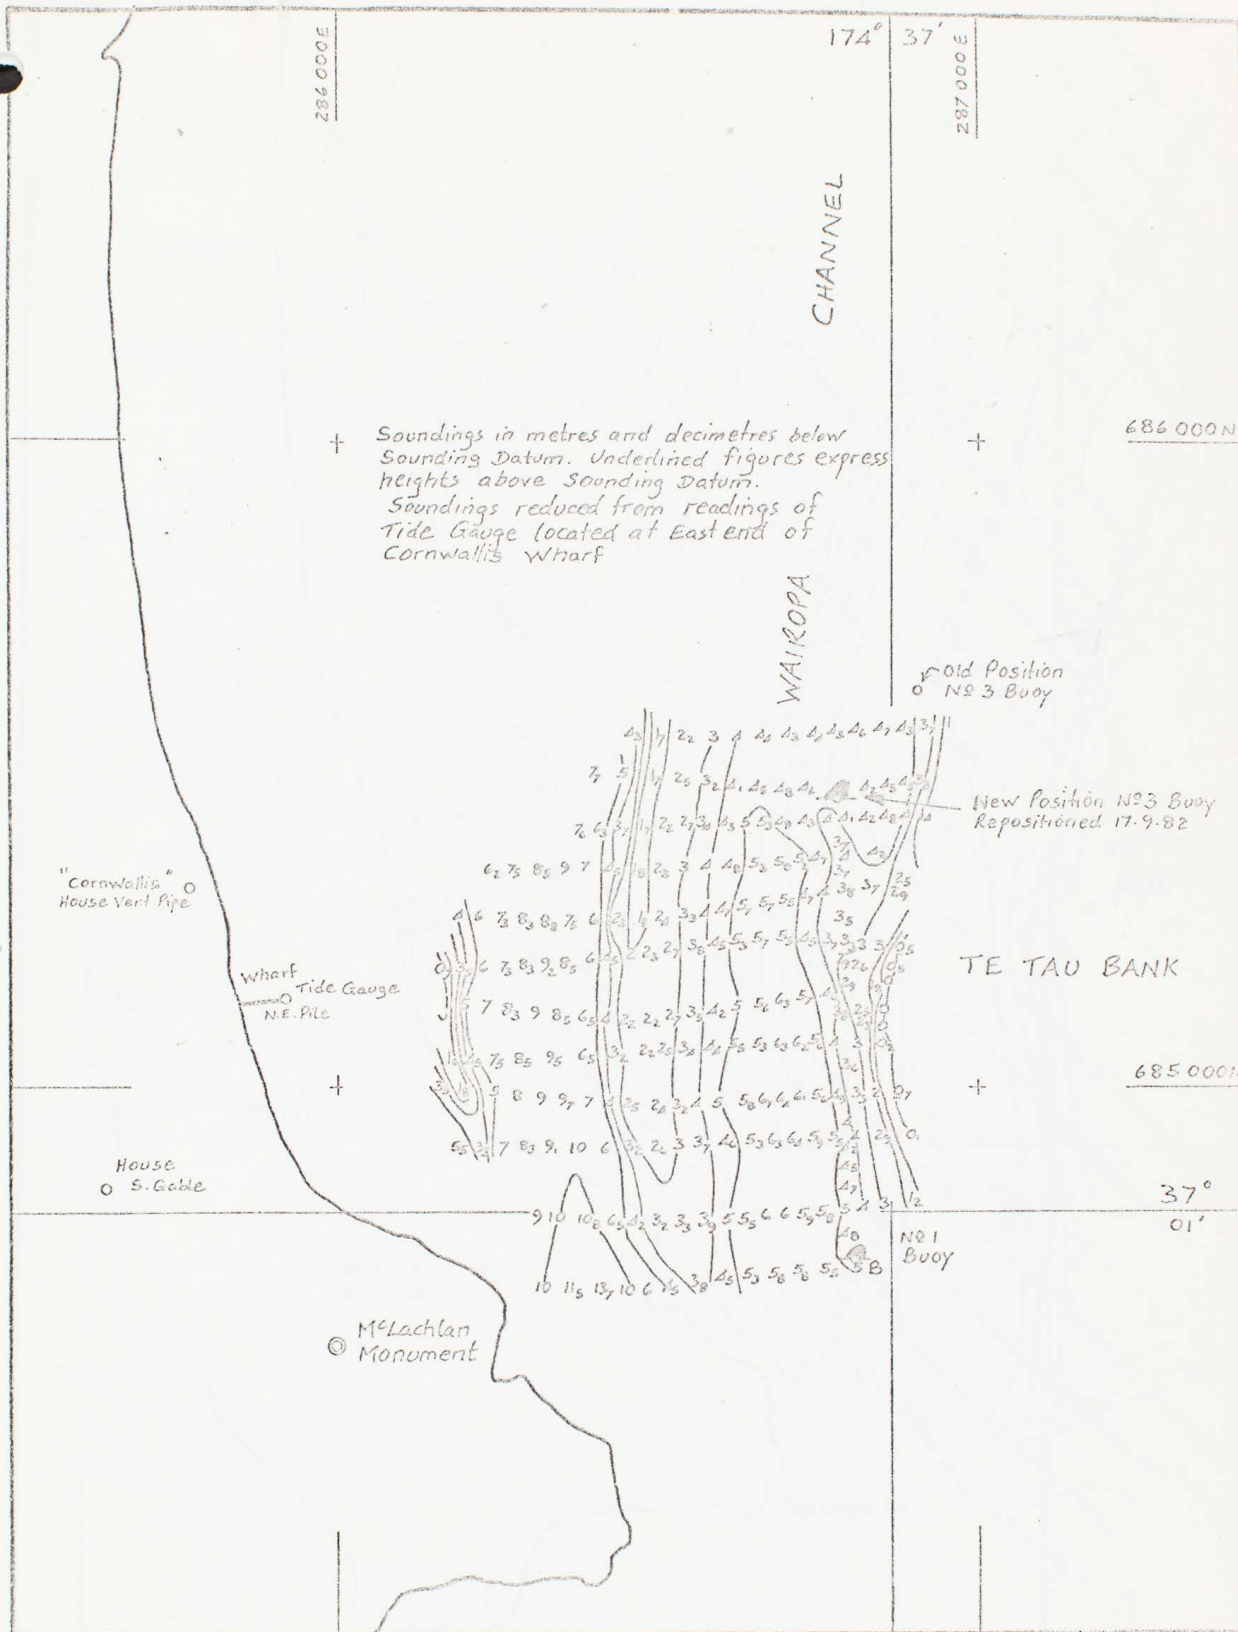
MANUKAU HARBOUR—WAIROPA CHANNEL
 BETWEEN BOOYS 1+3
 surveyed 17 Sept. 1982

Following reports that shoal depths were being found in Wairopa Channel between No.1 and No.3 buoys the area was resurveyed on 17 September 1982.

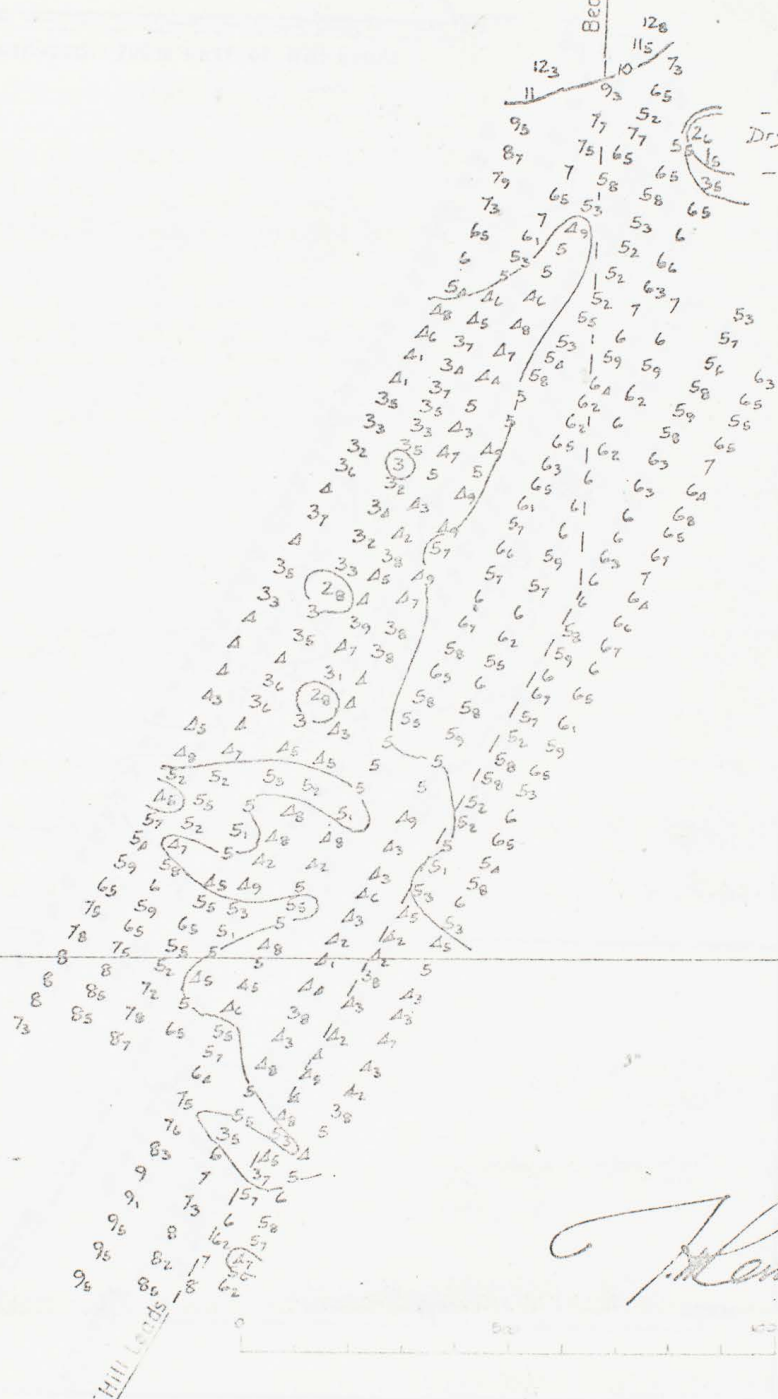
MANUKAU HARBOUR ENTRANCE
 SOUTH CHANNEL
 Surveyed 24. 11. 81
 Sounding in metres & decimetres below C.D.

A re-survey of the South Channel was carried out in very good sea conditions with negligible swell over the high water period between 0900 and 1000 on 24 November 1981.

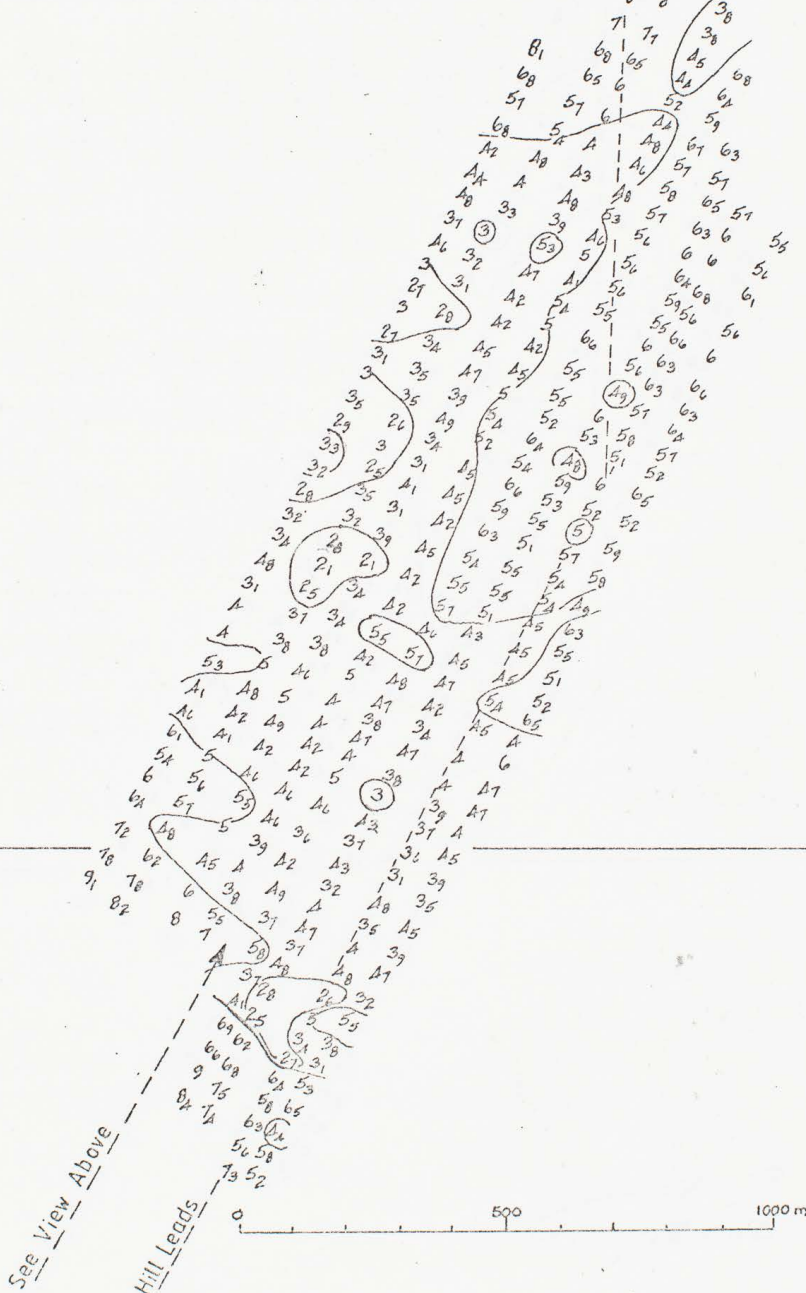
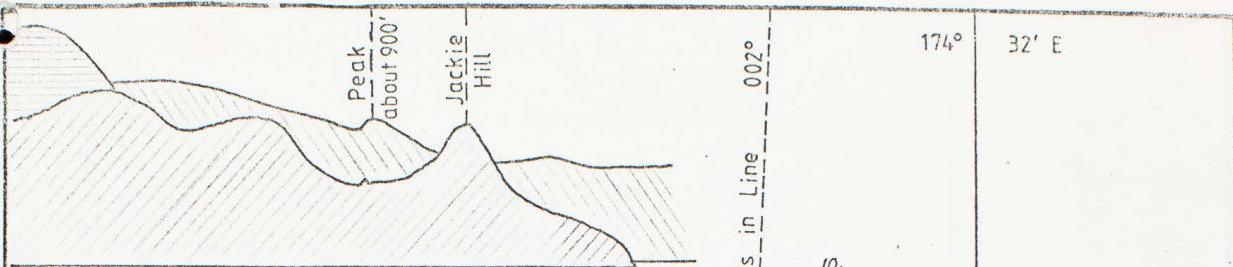
DRAWING
H5/1S/44
Amendment No. 7

An unsuccessful attempt to survey the South Channel was made on 13 October, aborted due to unsuitable sea state. On 15 October 1981 a survey was carried out in marginal conditions over the high water period between 1030 and 1200.

It is evident that the long period of strong westerlies that have prevailed over the past three months have caused a migration of sand now deposited on the shoal lying athwart the channel on the Hill leads to the west of the lighthouse. In general this shoal is in the same position as found in surveys since July 1980, major changes are as follows:-

1. A drying sandspit has appeared at the northern end of the channel to the east of Destruction Gully leads line.
2. Shoals with depths of less than 3 metres were found in the following positions:- (Bearings and distances from the lighthouse)
 - (a) Depth 2.1 metres 272° 1400 m.
 - (b) " 3.0 " 253° 1350 m.
 - (c) " 2.5 " 242° 1700 m.

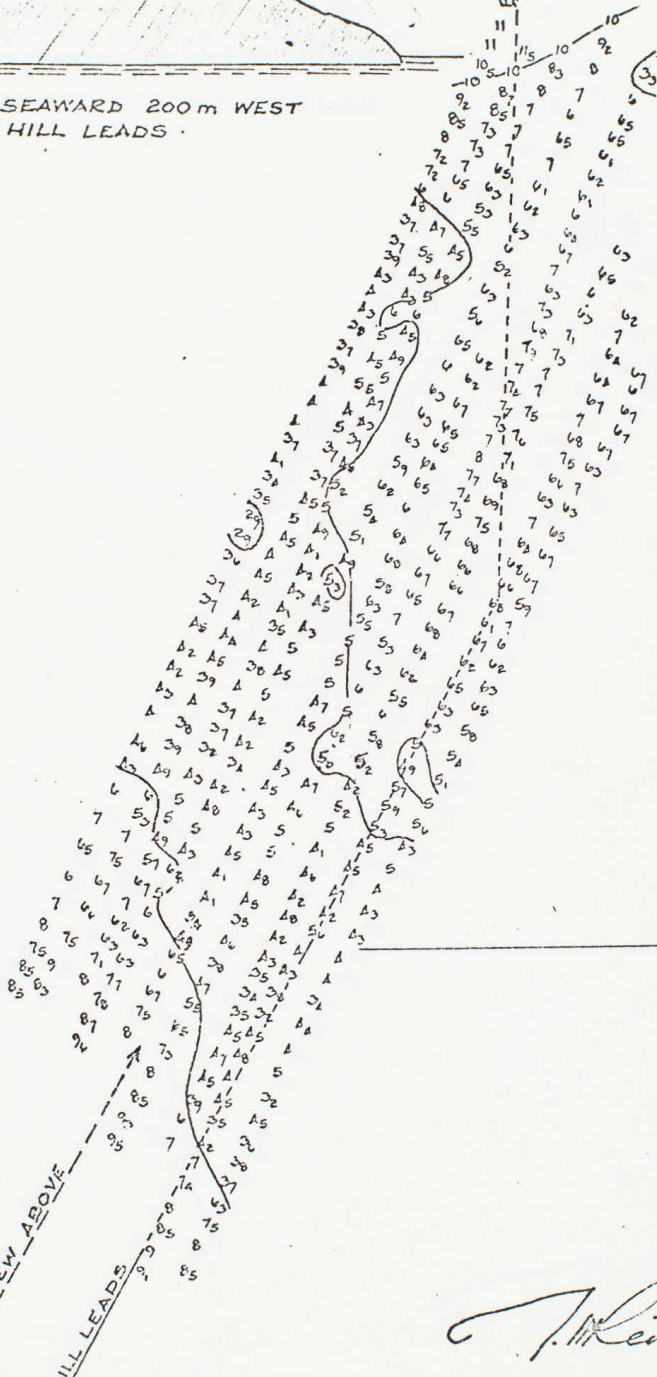
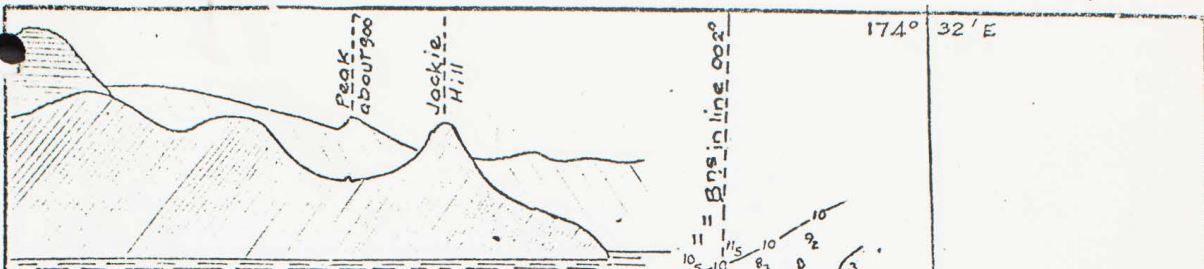
DRAWING
H5/18/44
Amendment No 5

A survey of the South Channel was carried out in good sea conditions just prior to High Water on 8 April 1981.

1. The Sandspit at the northern end of the channel on Destruction Gully leads has become re-established with depths averaging 4.5 metres.
2. The shoal lying athwart the channel on the Hill leads is still in the same position as found in the last two surveys, i.e. since July 1980.
3. The best approach would now appear to be on the Hill leads where a least depth of 3.8 metres exists in position 242½°, 1,550 metres from the Lighthouse. Good water also can be found on the previously recommended approach 200 m west of the Hill leads. (See Sketch of view from seaward on plan.)

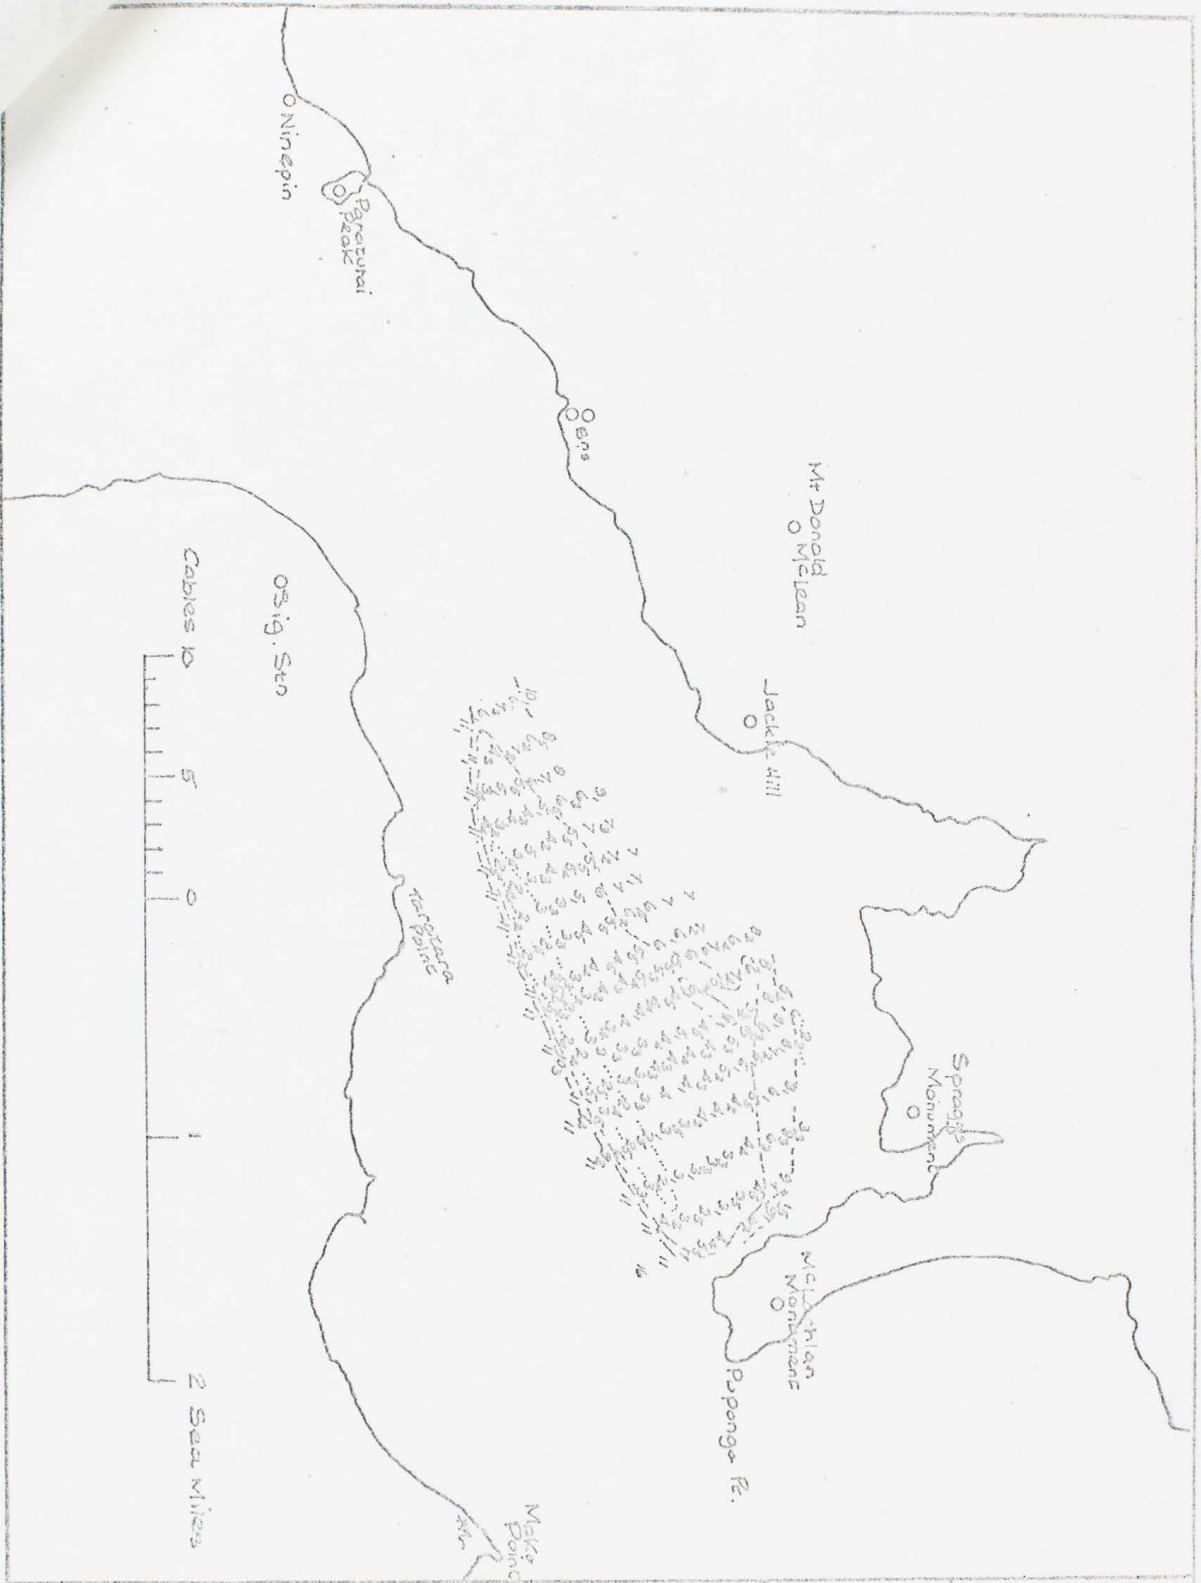
HUIA BANKS
 17.12.80
 Soundings in fathoms & feet below
 Chart Datum

The Survey reveals that the shoal has narrowed and its western limit has both extended westwards and swung to the south, effectively narrowing the gap between Taratara Point and the bank to about 4 cables. In view of this I would recommend that the buoy be repositioned about 7½ cables to the W.S.W. of its charted position, or 5 cables from its actual position.
