Manukau Harbour  
1000 Gen.

incl Survey of Harbour Entrance  
 Hydrographic Surveys.

MANUKAU ENTRANCE - REPORT OF SURVEY

MANUKAU HARBOUR ENTRANCE-SOUTH CHANNEL

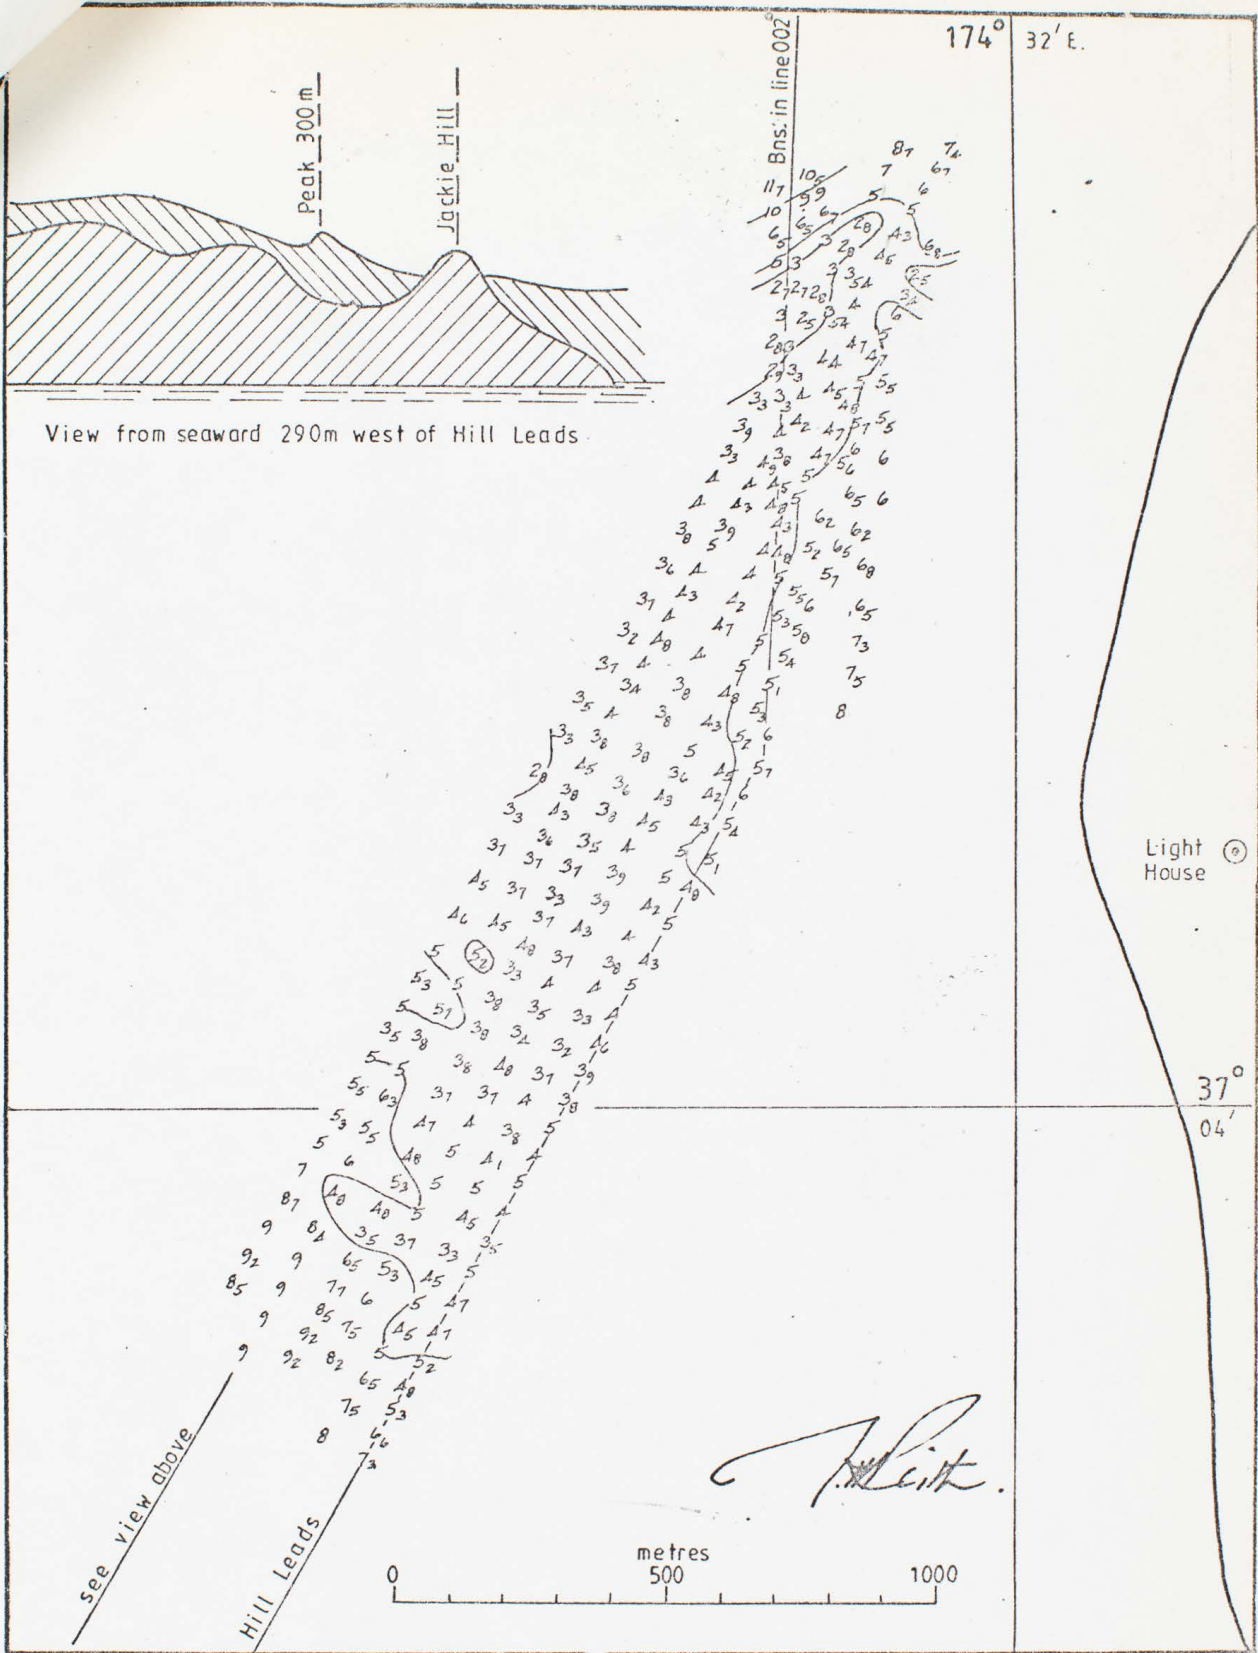
Amendment 4

Following a report from the Tugmaster that a channel appeared to exist, running through the Hill Leads with the 300 metre peak in the centre of the saddle, advantage was taken of the recent calm conditions and resultant plan, Amendment No. 4 to H.5/1/45, verifies this observation.

A 3 metre contour has been added which shows a breach through the shoal ridge giving a least depth of 4 metres through the breach 290 m to the west of the Hill Leads.

Hill Leads	3.5 m	242°	1,550 m	from the Lighthouse
Gully Leads	2.7 m	321°	1,320 m	" " "
and close S.E.	2.5 m	321°	1,250 m	" " "

A 2.8 metre shoal was located in position 277°, 1,300 metres from the Lighthouse 350 metres west of the Hill Leads.

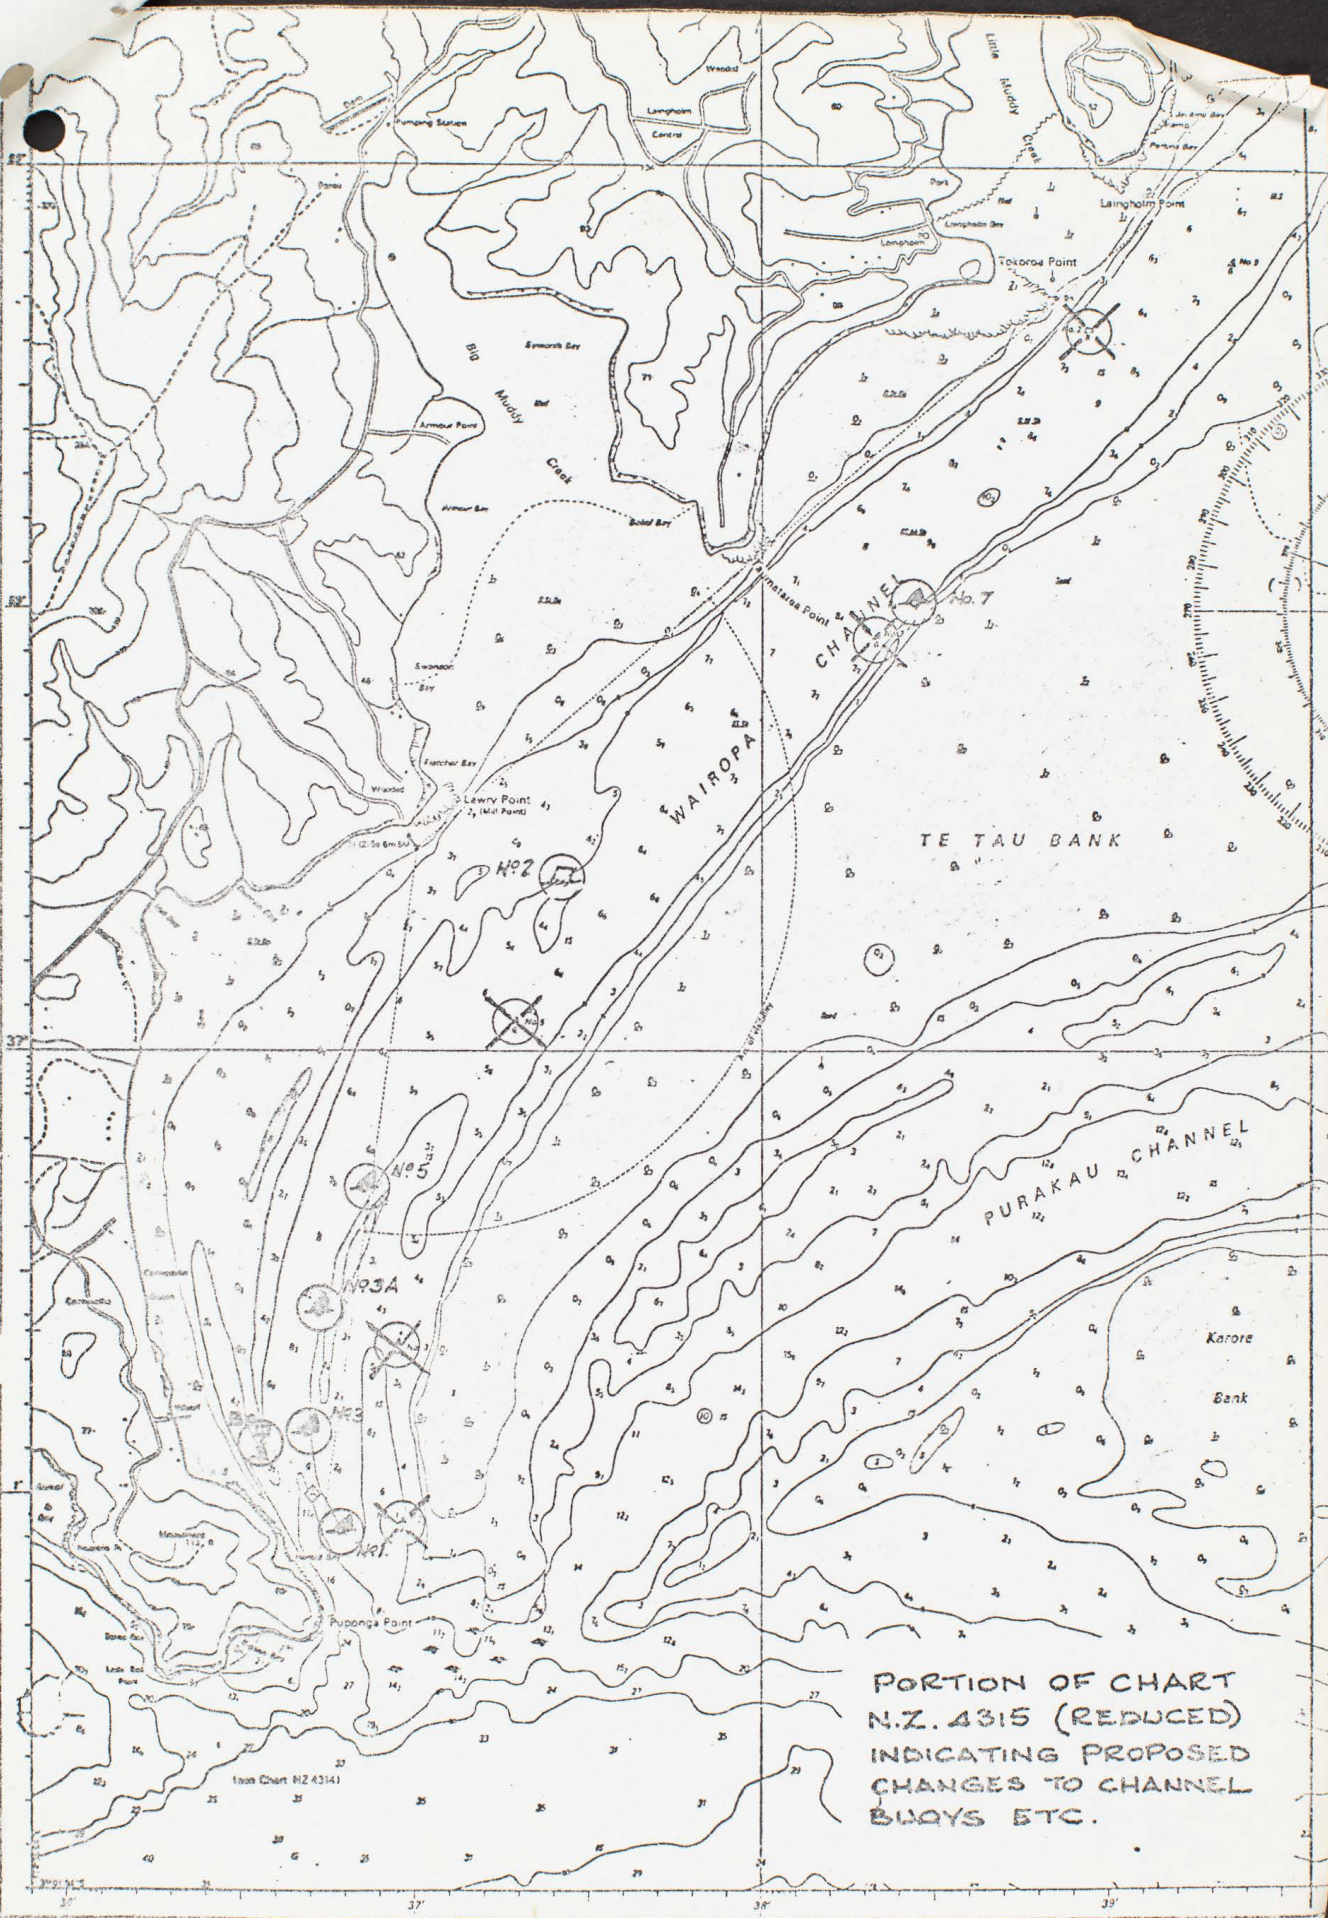
PORTION OF CHART  
 N.Z. 4315 (REDUCED)  
 INDICATING PROPOSED  
 CHANGES TO CHANNEL  
 BUOYS ETC.

The report and the work carried out on this survey is of a very high standard and clearly shows the shoaling that is taking place at the entrance to Wairopa Channel.

There is no doubt that the present marked channel will have to be moved to the west at the earliest opportunity and the following chartlet shows the repositioning of five buoys, the requirement of one new starboard hand buoy and a proposed beacon.

1. Place temporary buoys in positions no.1, no.3, no.3A, no.5 as circled on enclosed chartlet.
2. Make ready an additional starboard hand buoy marked 3A.
3. Inform those responsible for the work that buoys 1, 3, 5, 7 and 2 will be shifted to new positions at a suitable time to be arranged within the next two months.

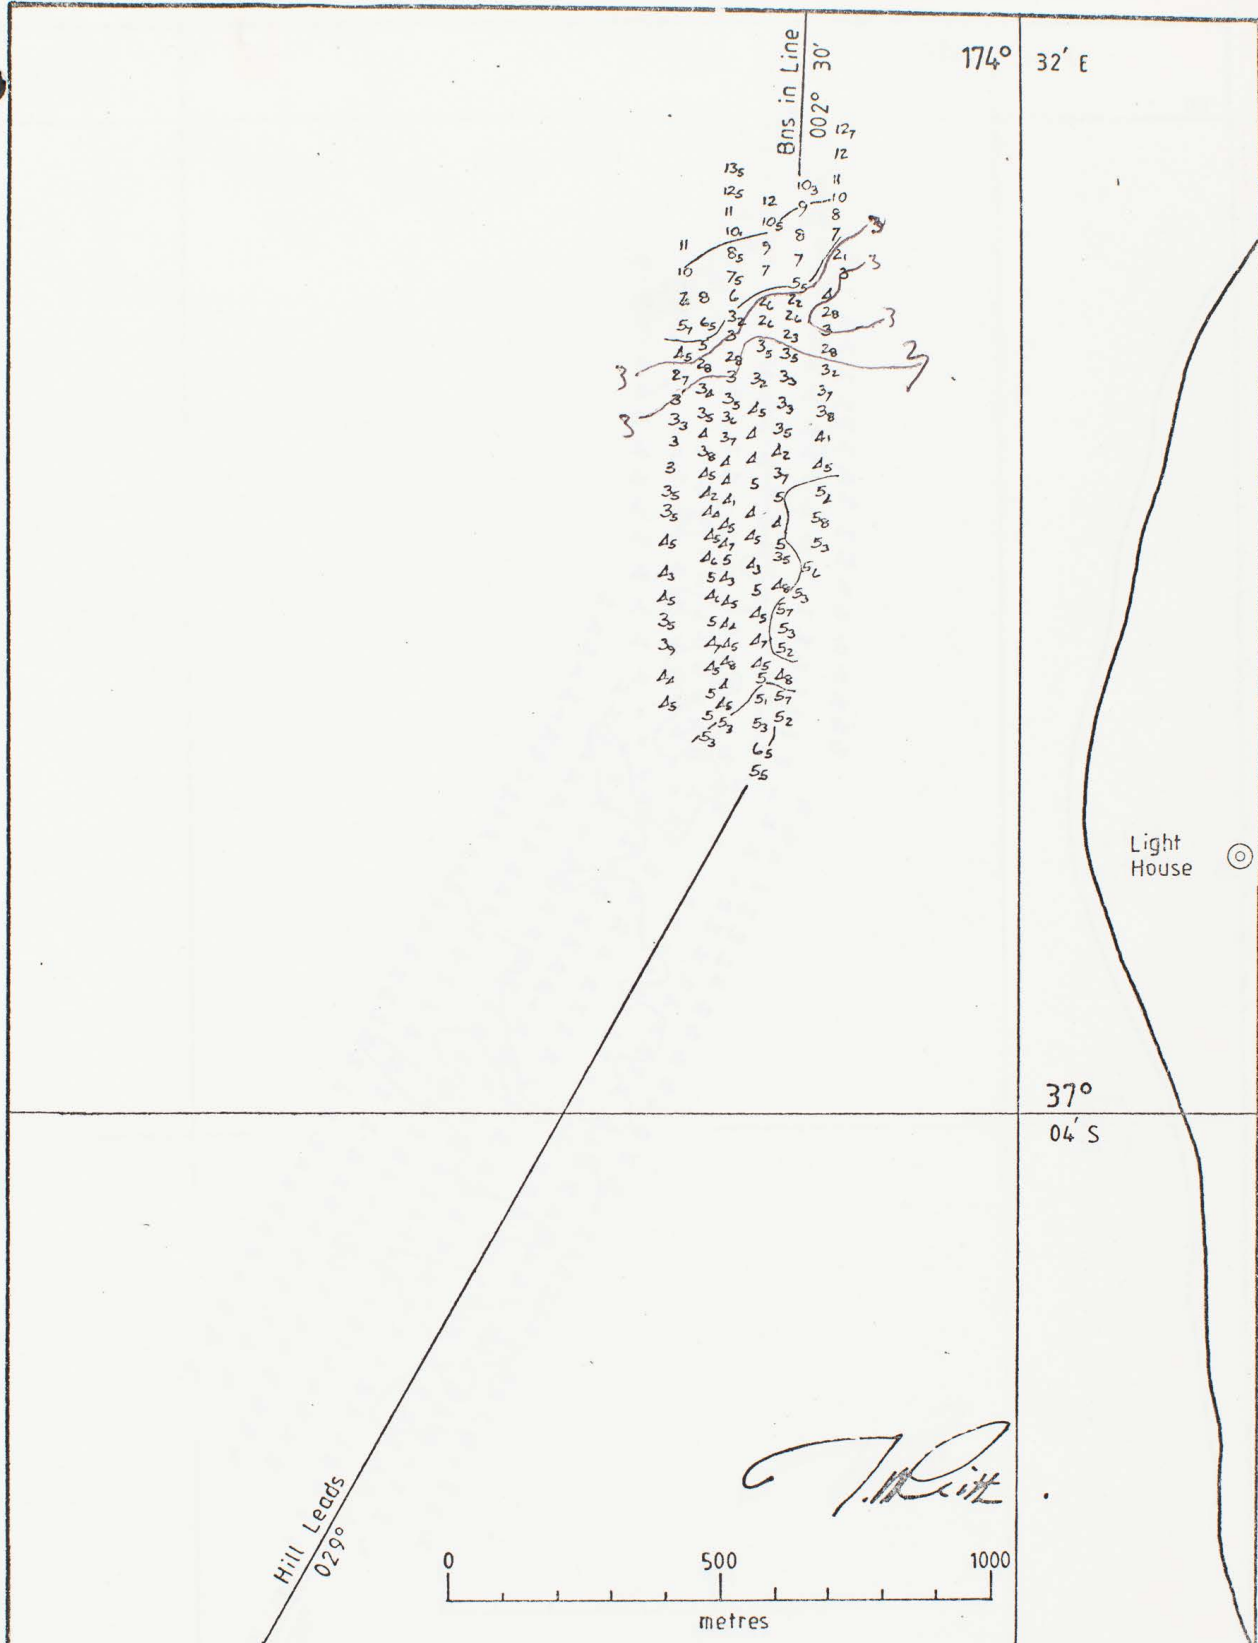
Amendment 3

Results, shown on Amendment No.3 to H5/1/45, confirm the above reports with a least depth of 2.2m on the Destruction Gully leads in position 321° 1310m from the Lighthouse. This lies on a ridge of sand extending to the NE and SW of the above position with better water found to the west of the leads.

This is the shoalest depth recorded in the south channel for many years and is probably due to the strong southwesterlies of last week during a neap tide. It is hoped that the spring tides this week will assist in improving depths.

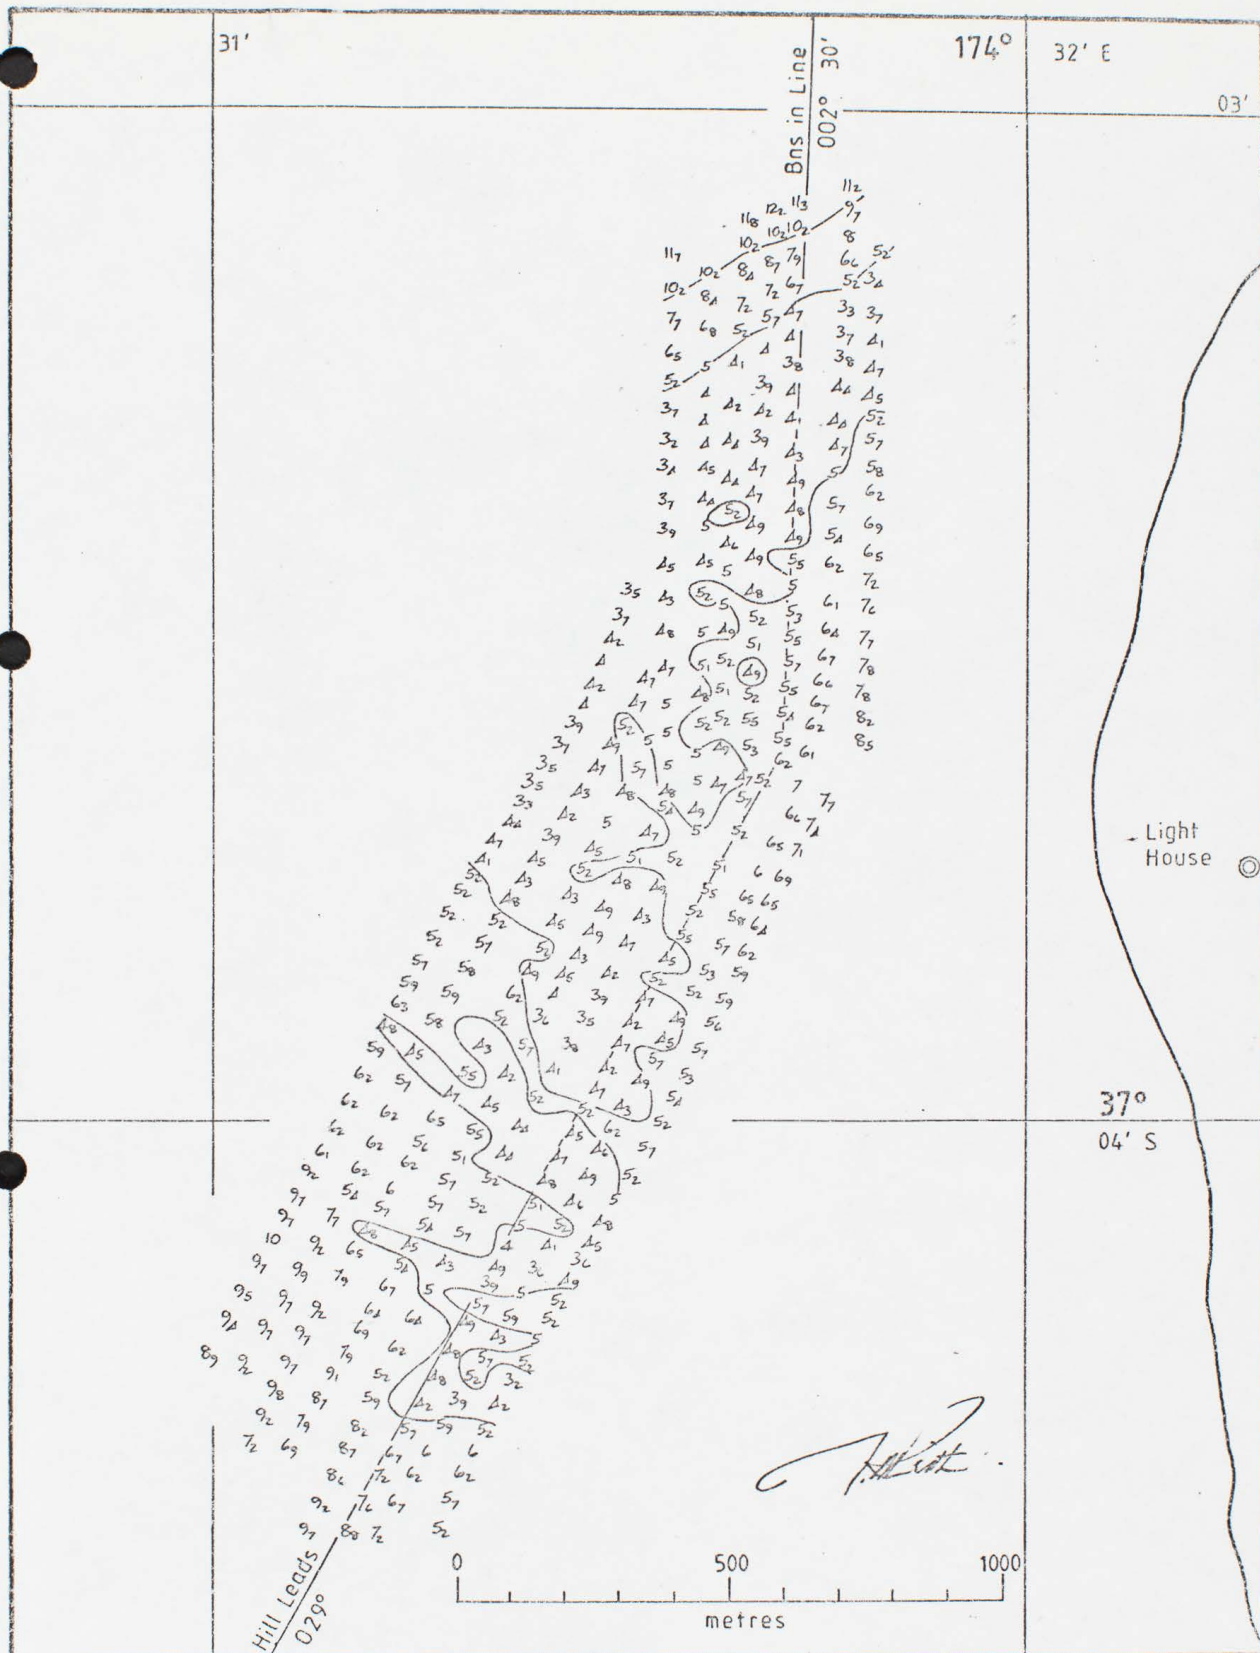
Amendment 2

The eastern extremity of South Bank now extends across the Destruction Gully leads line to join with the spit off South Head. The shoalest sounding on these leads was 3.8m 317°, 1250m from the lighthouse with a shoaler depth of 3.3m to the N.E. and 3.9m to the S.W.

The shoalest sounding obtained on the Hill Leads was 3.9m 241° 1600m from the lighthouse.

The best approach is now directly along both sets of leads with a controlling depth of 3.8m.

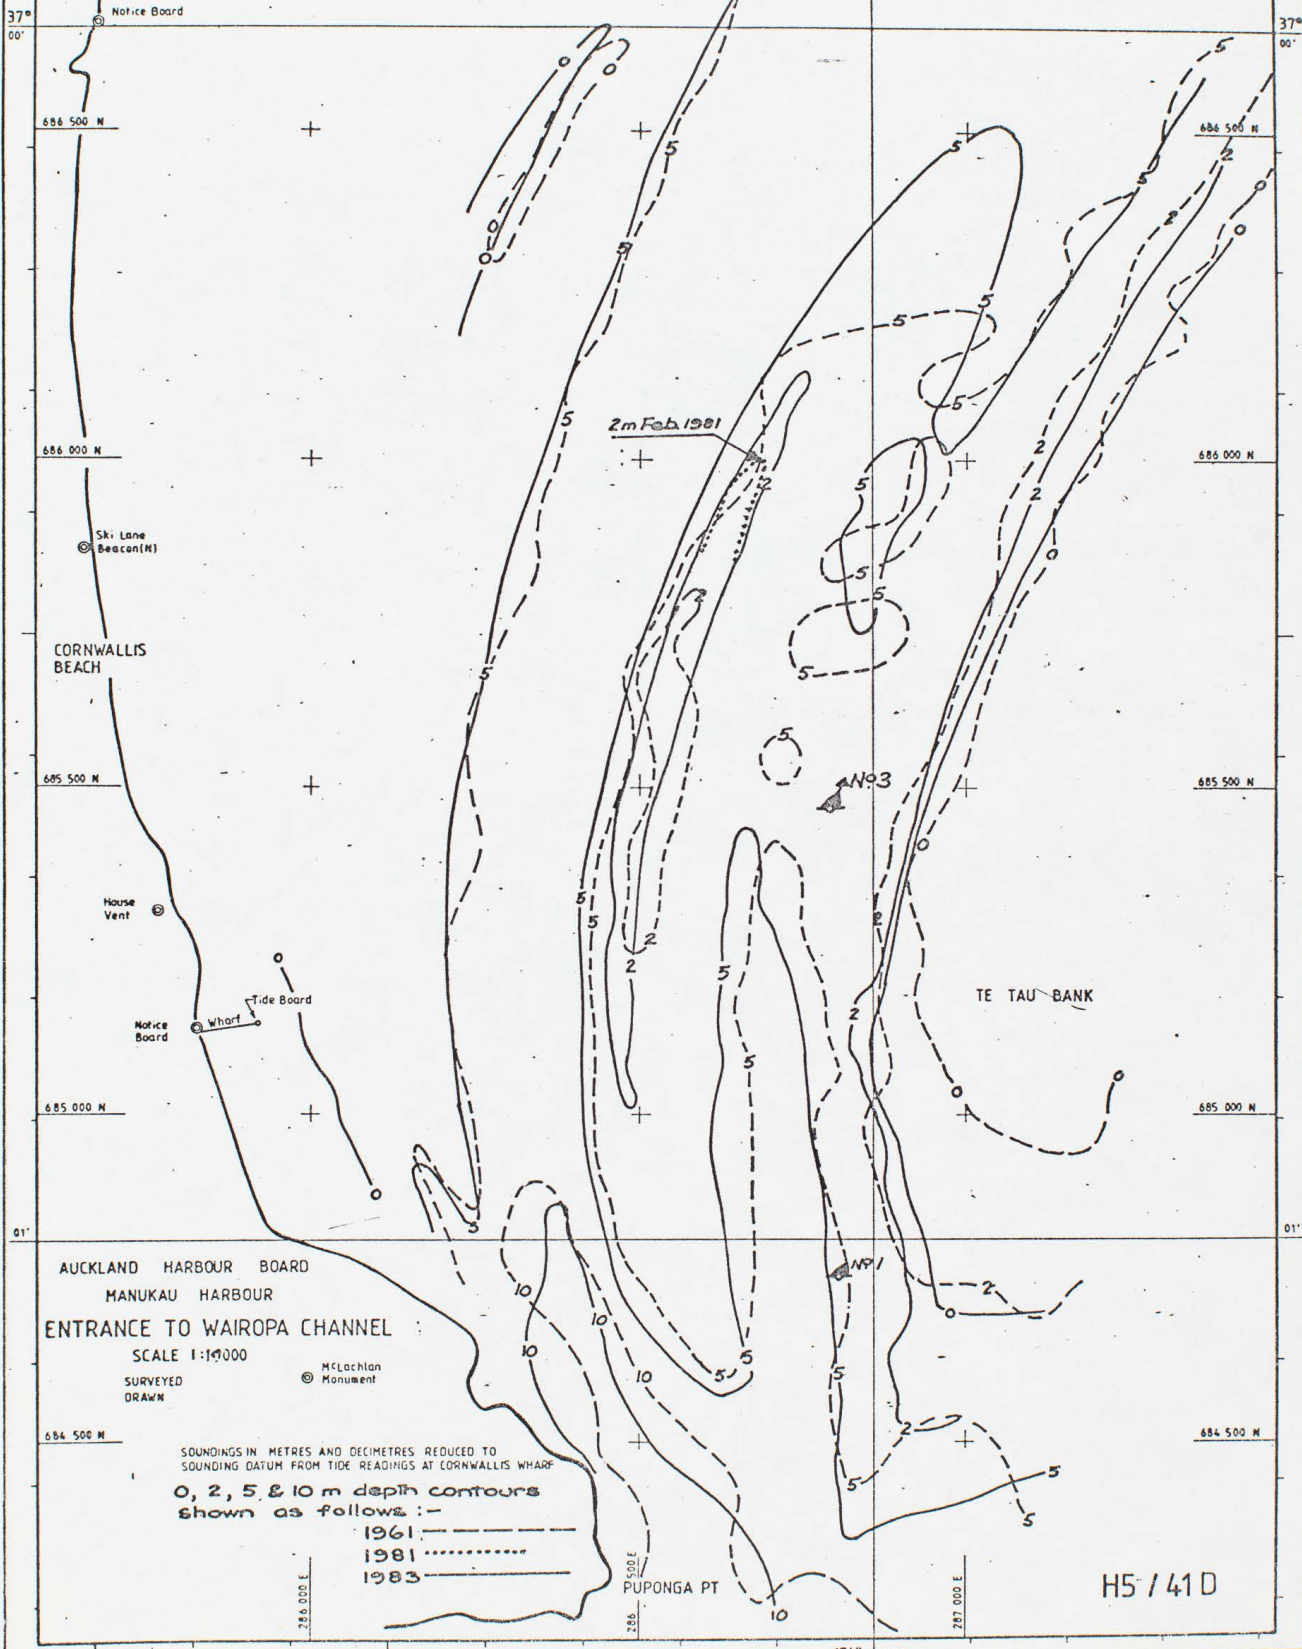
Selected contours from these three surveys are shown on H5/41D to assist in showing the change in bathymetry that has occurred over the past 22 years.

The unstable nature of Te Tau Bank which became manifest some three years ago has resulted in the following three main changes in bottom Topography:-

1. Since 1961 the southern extremity of the Tau Bank has extended 280m to the south.
2. Over the same period the unnamed bank of less than 2m depth to the west of No.3 buoy and referred to in this report as "Middle Bank" has extended in length from 550m to 1,160m and decreased in depth. Since 1981 the northern end of Middle Bank has extended by 150m with decreased depths over its northern part averaging 0.3m
3. In the currently used buoyed channel to the west of No.3 buoy depths have, on average, decreased by 1 metre since 1961, half of this shoaling occurring during the past two years.

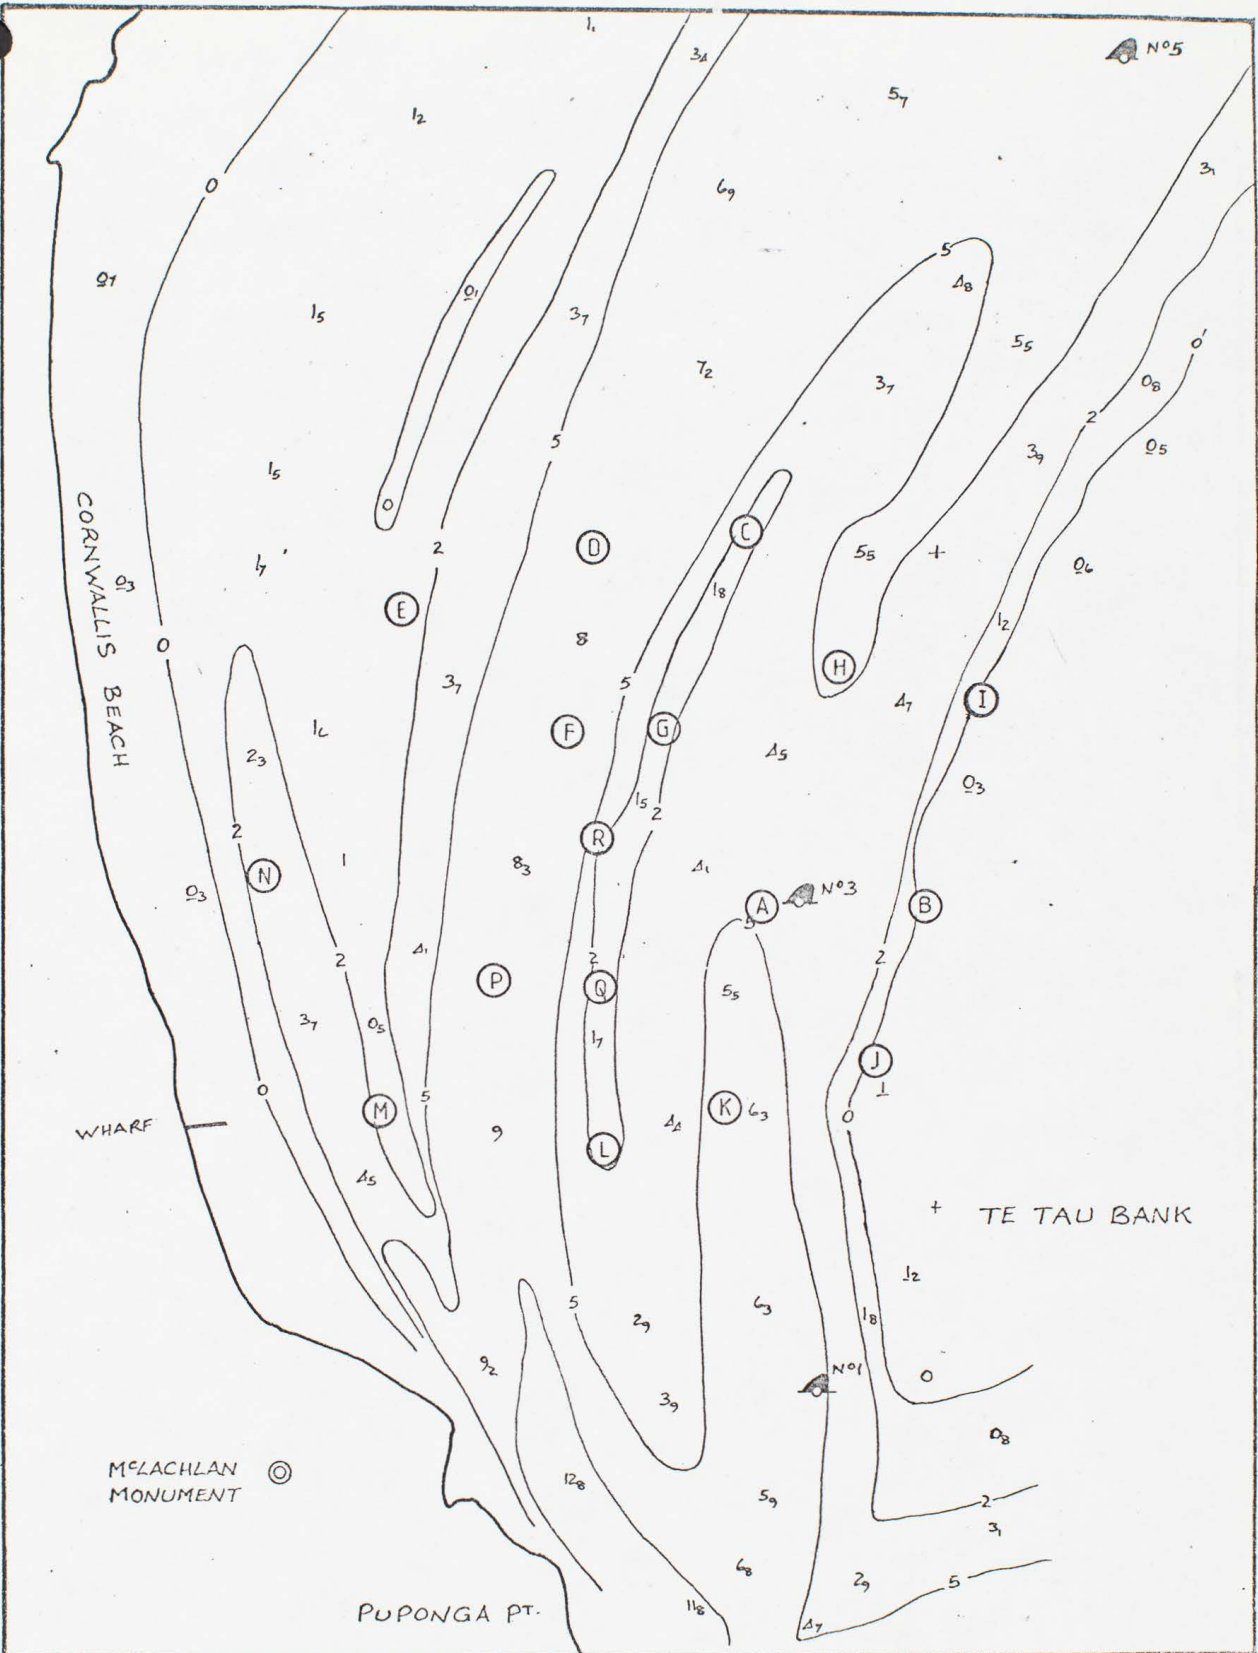
DRAWING  
H5/A1C

Seventeen bottom samples were obtained by dredge, their locations shown on plan H5/41C. The nature of harbour bed material overall is predominantly a very fine black sand with varying traces of silts. Samples at H and N yielded broken shell.

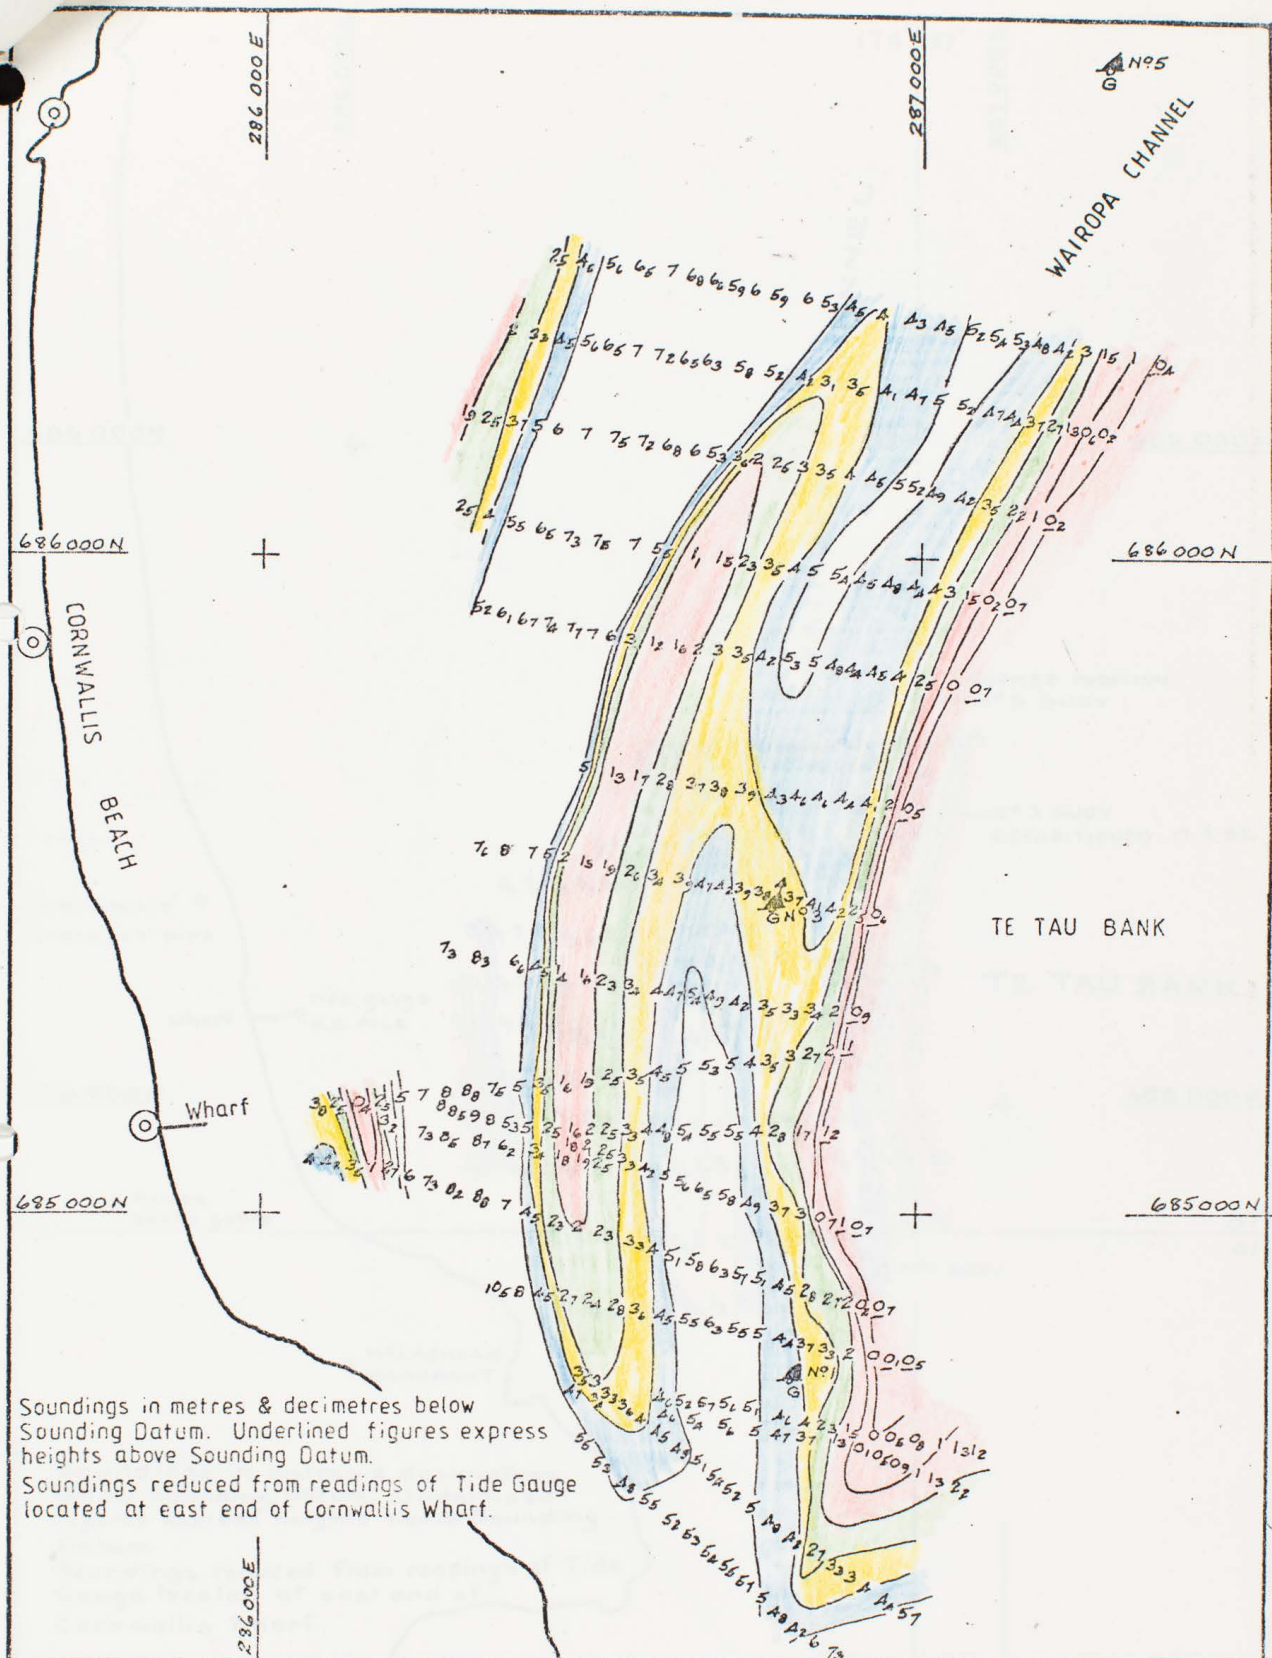
DRAWN JHR	DRAWING H5/34 Amendment 2
DATE 18-4-83	
SCALE 1:10,000

Results of this survey are shown as amendment No.2 to plan H5/34 (January 1981). For comparison purposes the relevant portion of H5/34 and amendment No.1 (September 1982) are appended.

This latest survey indicates considerable changes in the buoyed channel with shoaling between Te Tau and the middle bank to the westward. This middle bank has become shoaler and extends further to the north and south of its 1981 limits.

A more comprehensive survey is necessary to determine the full extent of these changes. At present it would appear that sand from the Te Tau Bank is being transported across the channel and deposited along the middle bank. Should this trend continue and depths in the navigational channel diminish further some consideration may have to be given to using the deeper channel to the west of the middle bank.

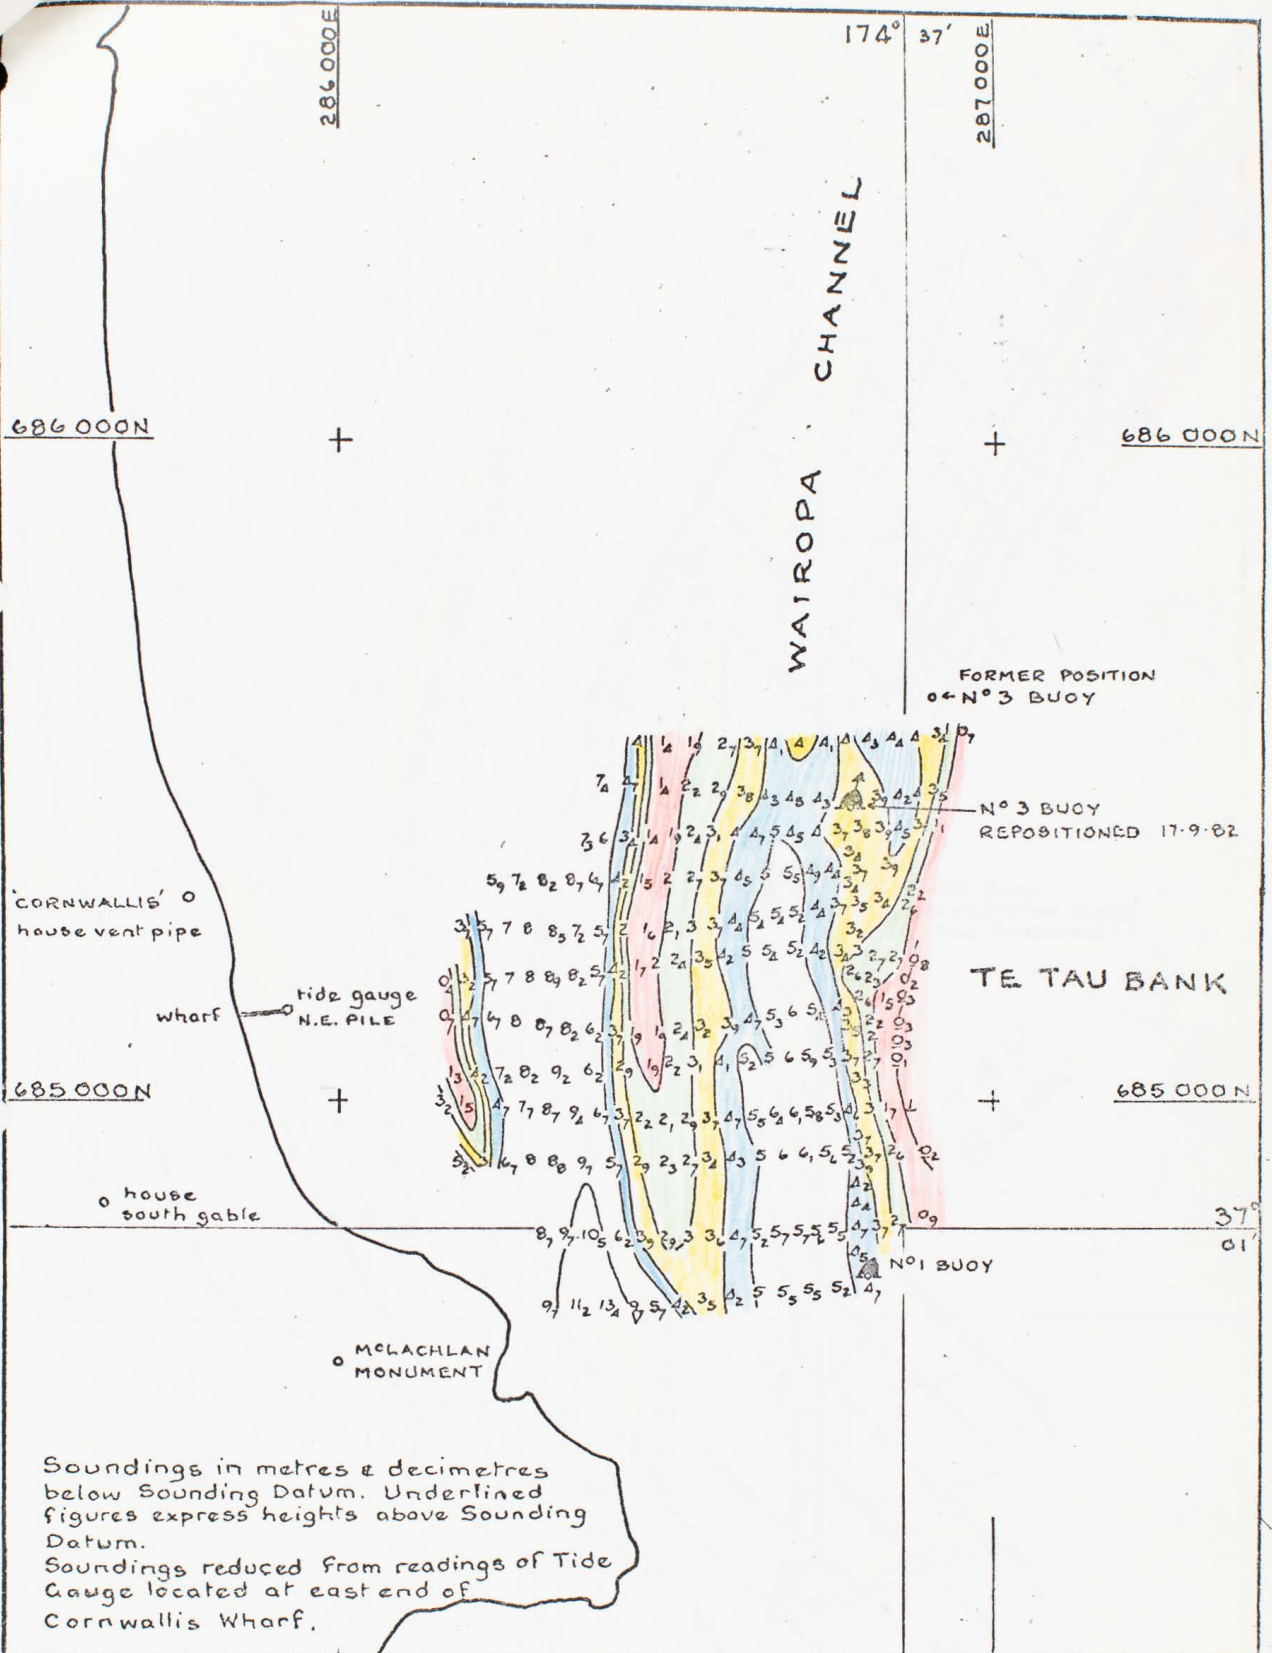
DRAWING  
H5/34  
Amendment 1

Instability of Te Tau Bank was first detected in July 1980 when it was found that the tail of the bank had extended to the South and Nos. 1 and 3 buoys were moved accordingly. In September 1982 No.3 buoy was moved to the SW to counter a westward movement of the bank.
