SUBJECT MANUKAU HARBOUR - GENERAL.

incl. SURVEY OF HARBOUR ENTRANCE - HYDROGRAPHICS SURVEYS.

MANUKAU HARBOUR ENTRANCE  
**SOUTH CHANNEL**  
Surveyed 29 Nov 1985

MANUKAU ENTRANCE - REPORT OF SURVEY - SOUTH CHANNEL

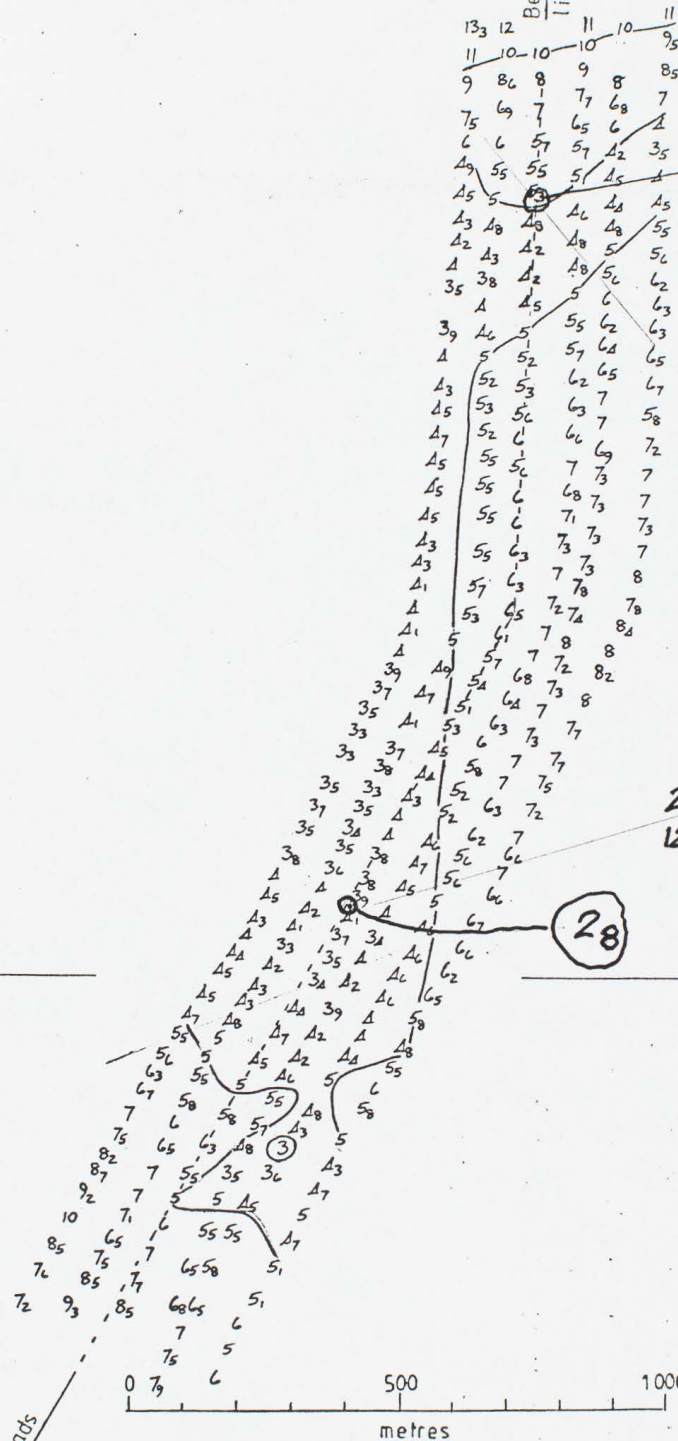
DRAWING  
**H5/1/45**  
Amendment 13

During an unsuccessful attempt to survey the South Channel the following shoals were located :-

1. A depth of 2.7m on The Destruction Gully leads  $320^\circ$ , ~~1300~~<sup>1270</sup>m from The lighthouse.
2. A depth of 2.8m on The Hill leads  $253^\circ$ , 1200m from The lighthouse.

Until a complete resurvey can be carried out it is suggested that deeper draught vessels be recommended to use the channel through The Western Shoals.

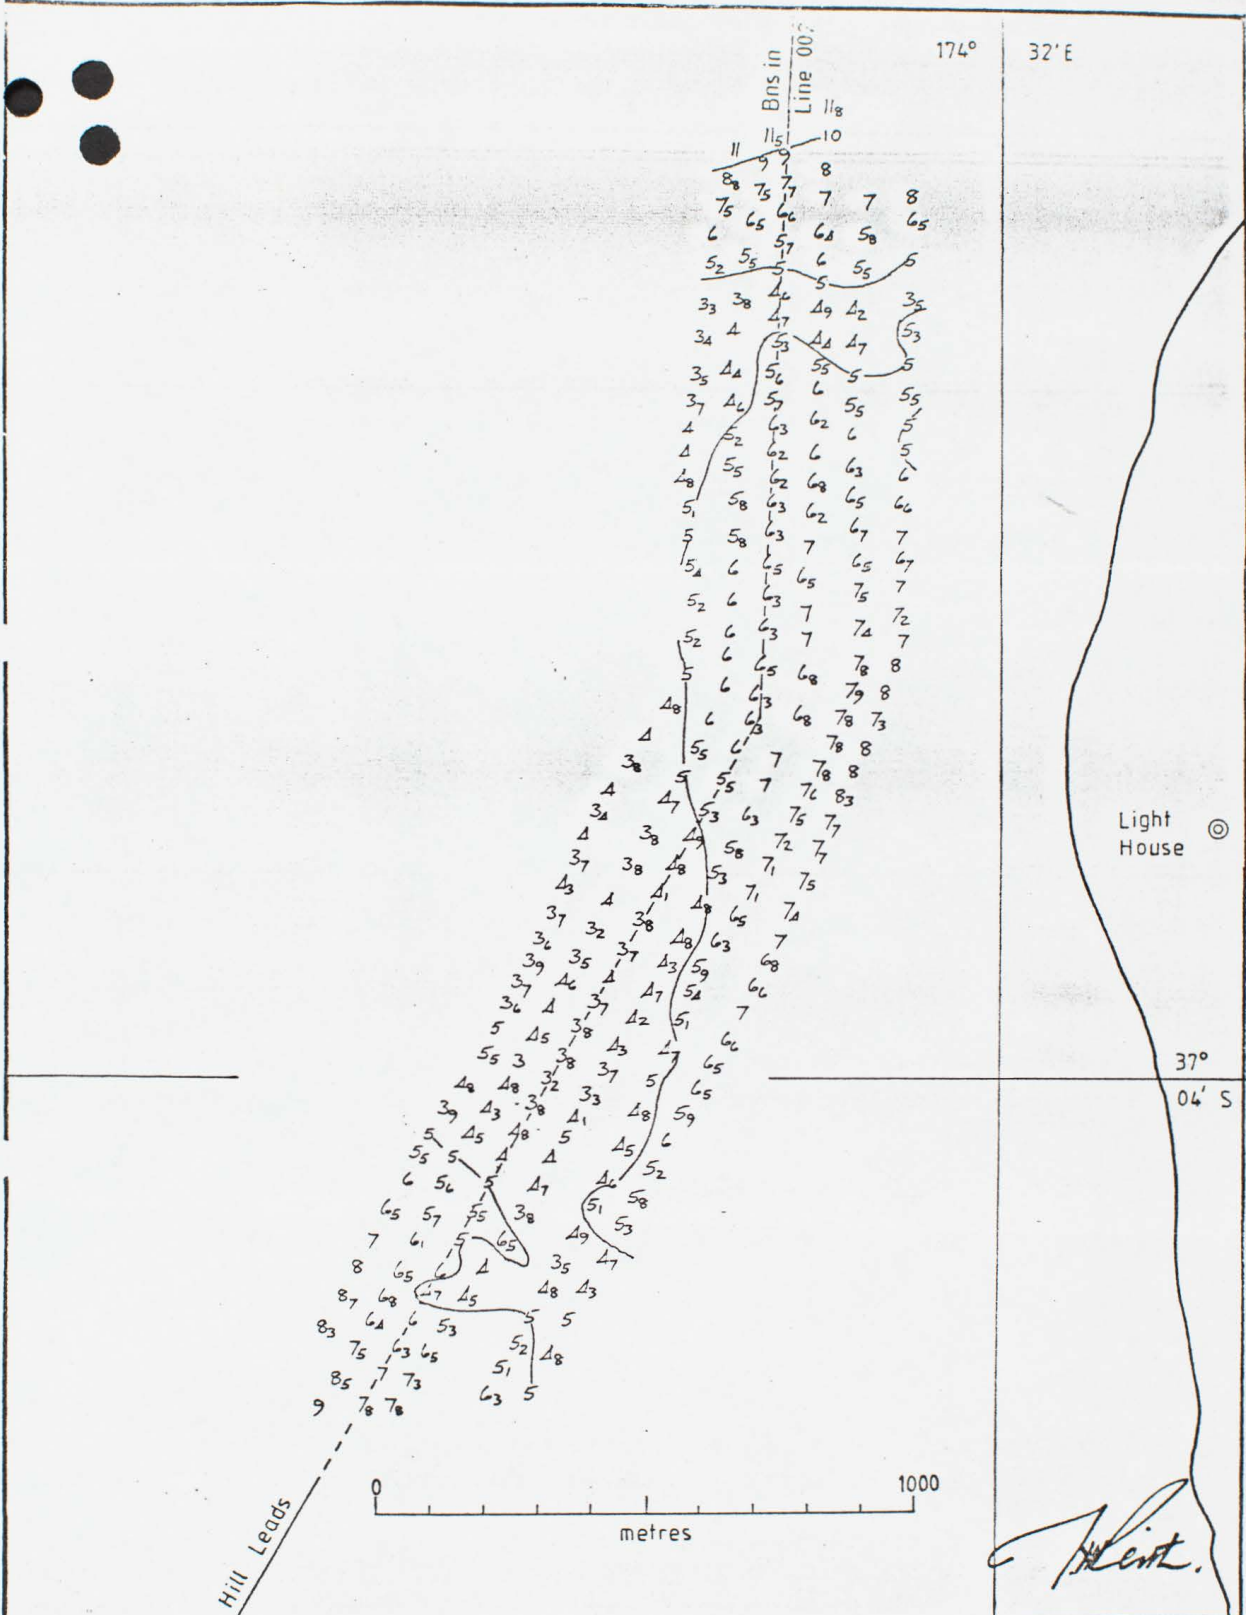
MANUKAU HARBOUR ENTRANCE-SOUTH CHANNEL	DRAWN <i>A.W.B.</i>	DRAWING H5/1 / 45 Amendment 12
	Surveyed 9 AUG 1985	DATE 12-8-85	
	Soundings in metres & decimetres below C.D.	SCALE 1:12000

Plans H5/1/45 Amendment 12 shows a migration of sand lying ~~at the~~ <sup>athwart</sup> the Hill leads to the south west of the light house.

An improvement in depths had occurred since the report referred to above but a general deterioration has taken place in this area since the survey of 25 June.

The least depth on the Hill leads was 3.2m in position 249°, 1340m from the lighthouse. A 3.0m depth lies close west and 3.3m close east.

The least depth on the Destruction Gully leads remains at 4.6m.

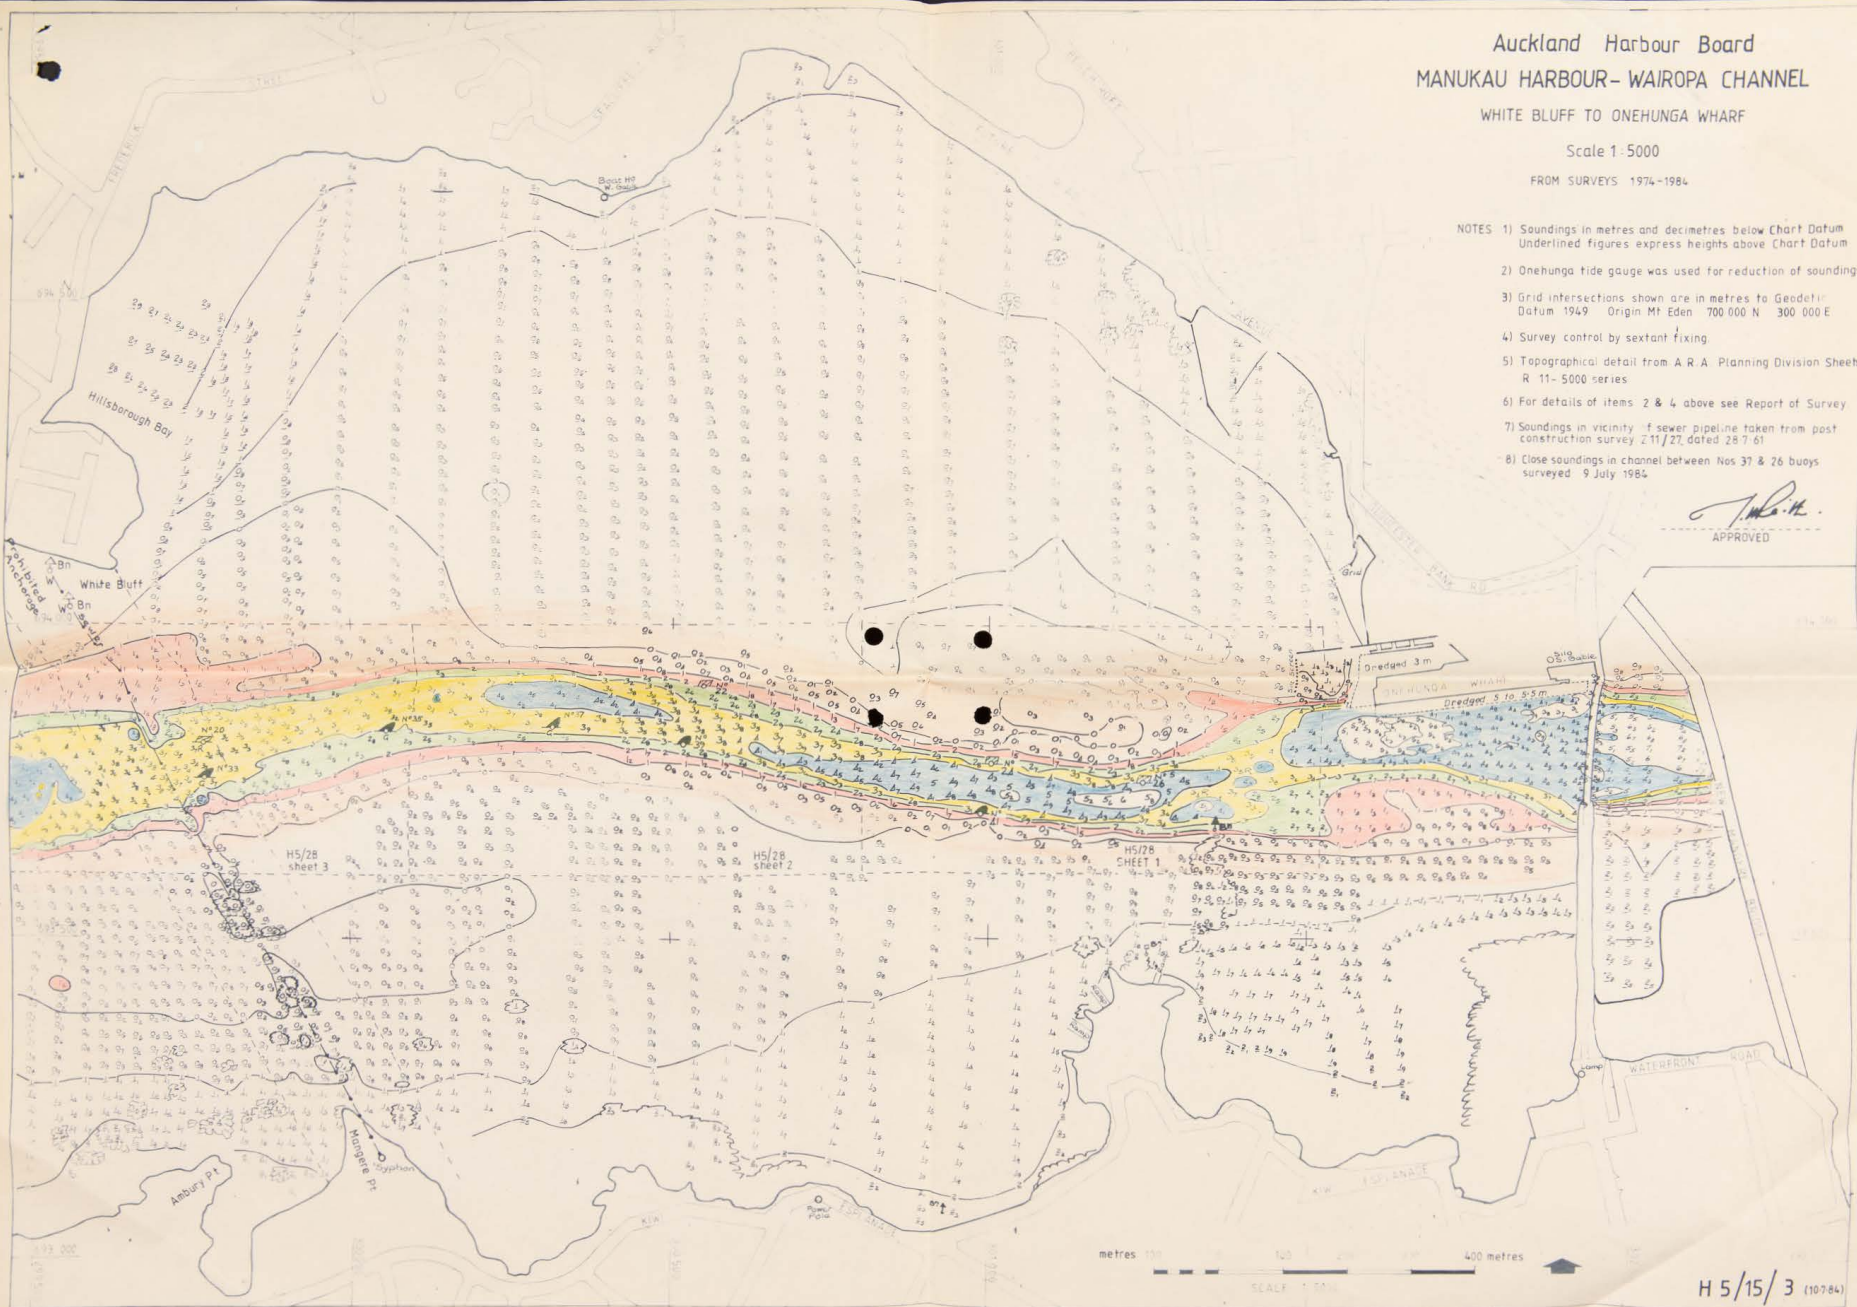
Auckland Harbour Board  
MANUKAU HARBOUR-WAIROPA CHANNEL

This survey (Plan H5/15/3) indicates no change to the 3m and shoaler contours on each side of the channel but does indicate that shoaling of up to 0.5m has occurred at channel centre between 39 and 41 buoys since 1978. To the eastward of No.41 buoy the shoaling is less and the sounding of 6m SW of No.26 buoy shows an increase in depth at this point.

These changes may be due to normal seasonal migration of bed material but may also be caused by discharged silts from the trawler basin. At present channel depths in this area are still in excess of the controlling depth of 3.2m but a programme of monitoring this section of channel annually will be programmed.

To assist those handling ships at Onehunga copies of the 1:1000 survey plans from White Bluff to the Wharf in composite form are being issued to the Harbourmaster and Officer-in-Charge Onehunga. A pecked outline of the largest vessel to normally

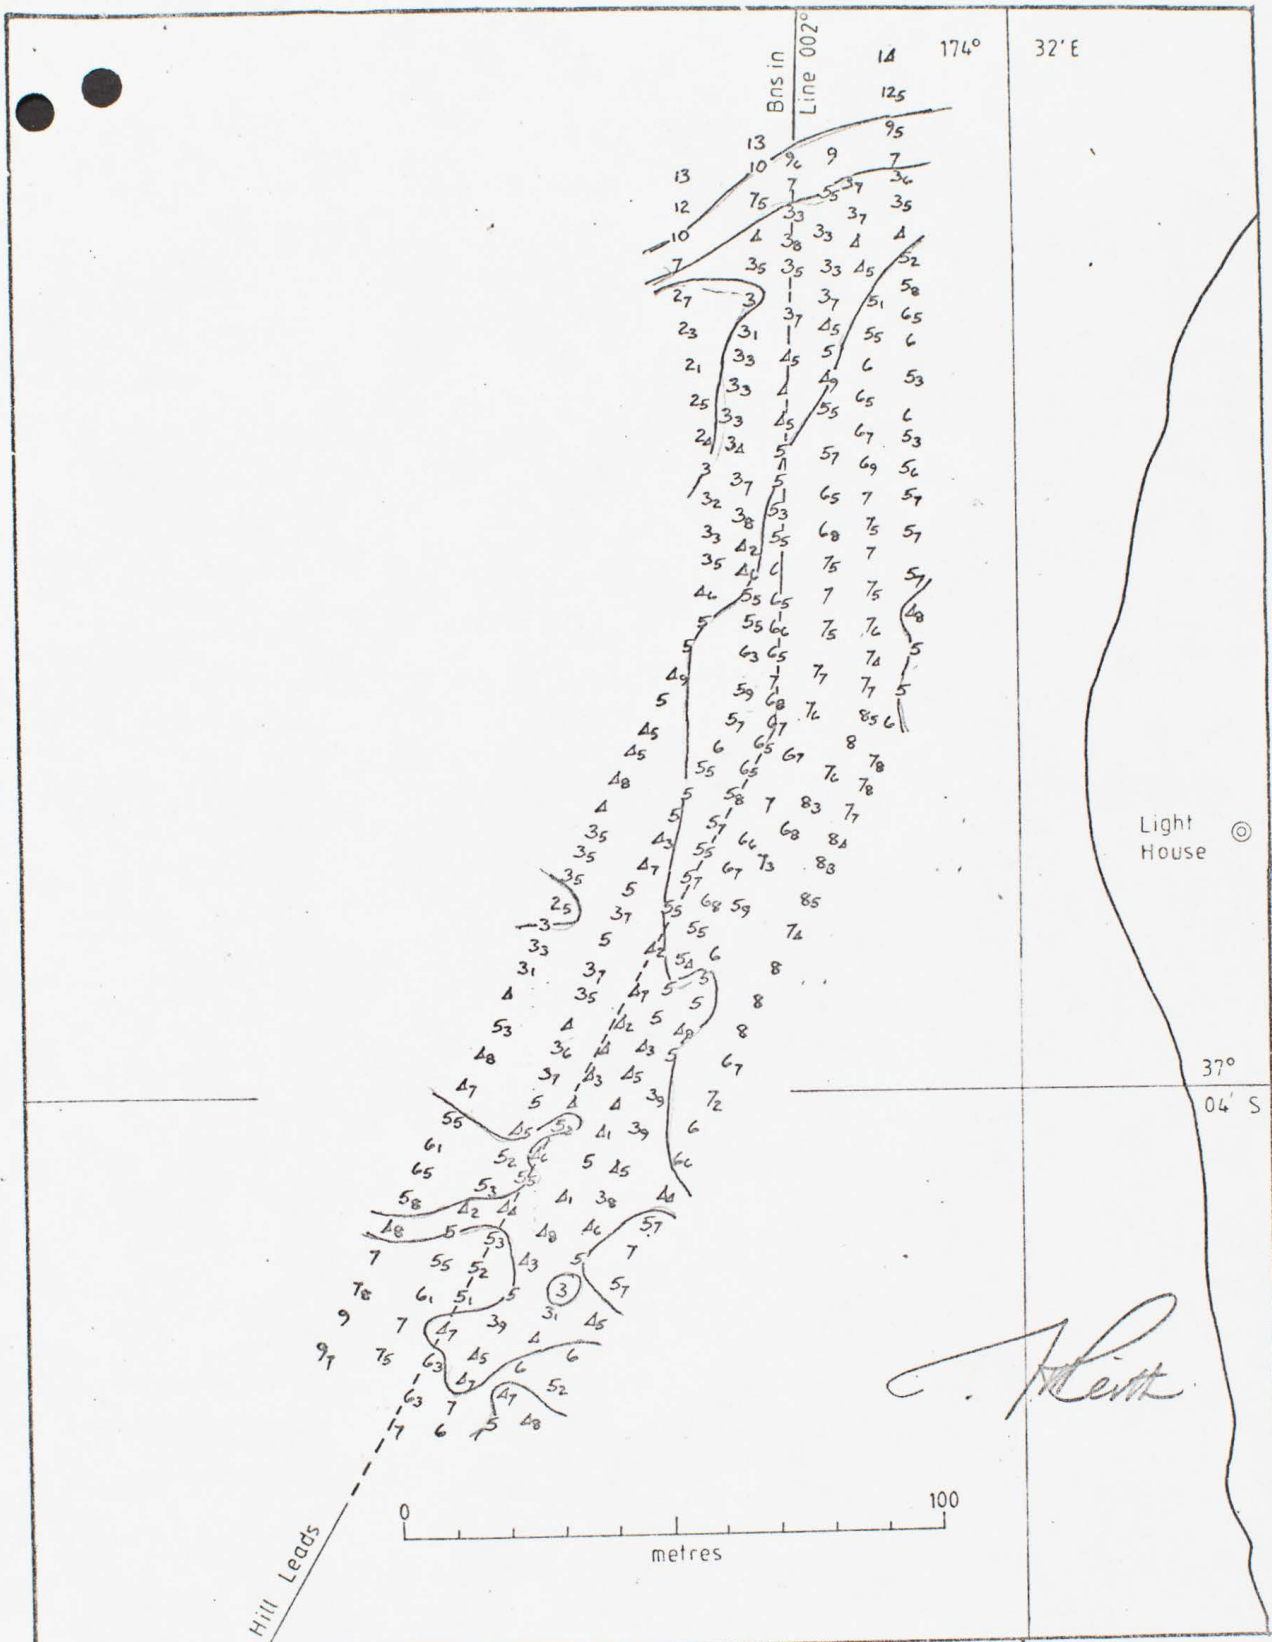
DRAWING  
 H5/1/45  
 Amendment 8

Similar results to the survey of 23/2/84 on the Gully leads. The sandbank of less than 3m still remains close westward at the northern end of the leads and has shoaled. The best water is to be found directly along both sets of leads where least depths found were as follows (Bearings and distances from the lighthouse):-

Hill Leads	4.0m	248°	1340m
	4.0m	252°	1250m
Gully Leads	<u>3.3m</u>	325°	1410m

MANUKAU HARBOUR ENTRANCE-SOUTH CHANNEL  
 Surveyed 7 May 1984  
 Soundings in metres & decimetres below C.D.

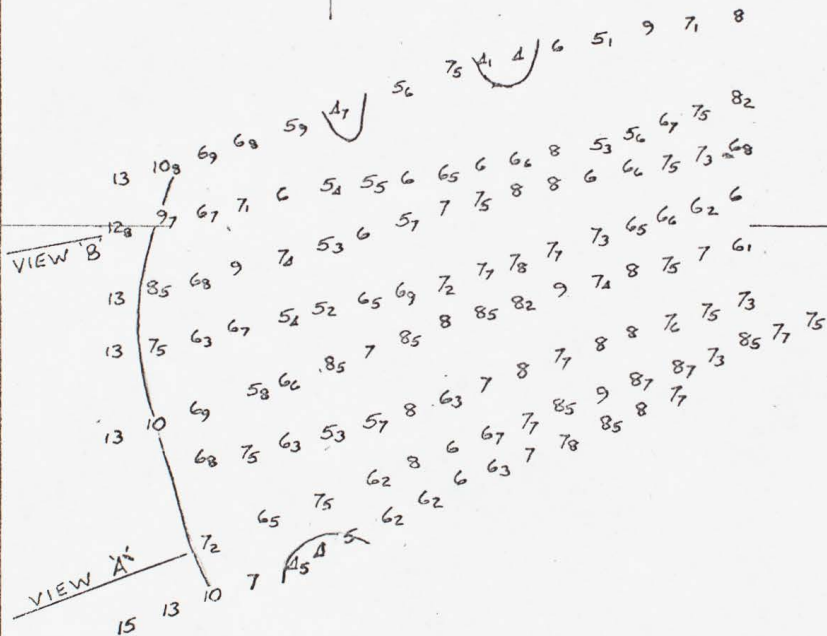
H5/1/46

Considerable improvement has taken place since the survey of 22/284.

Depths in excess of 5m were found from the southern transit, with Ninepin Rock in line with the southern edge of Paratutai Island, to a line where Ninepin Rock is two widths

open to the south, giving a natural channel width of 600m.

It is understood that this channel is not being used because of a local report that a shoal has been located there.

MANUKAU HARBOUR ENTRANCE-WESTERN SHOALS

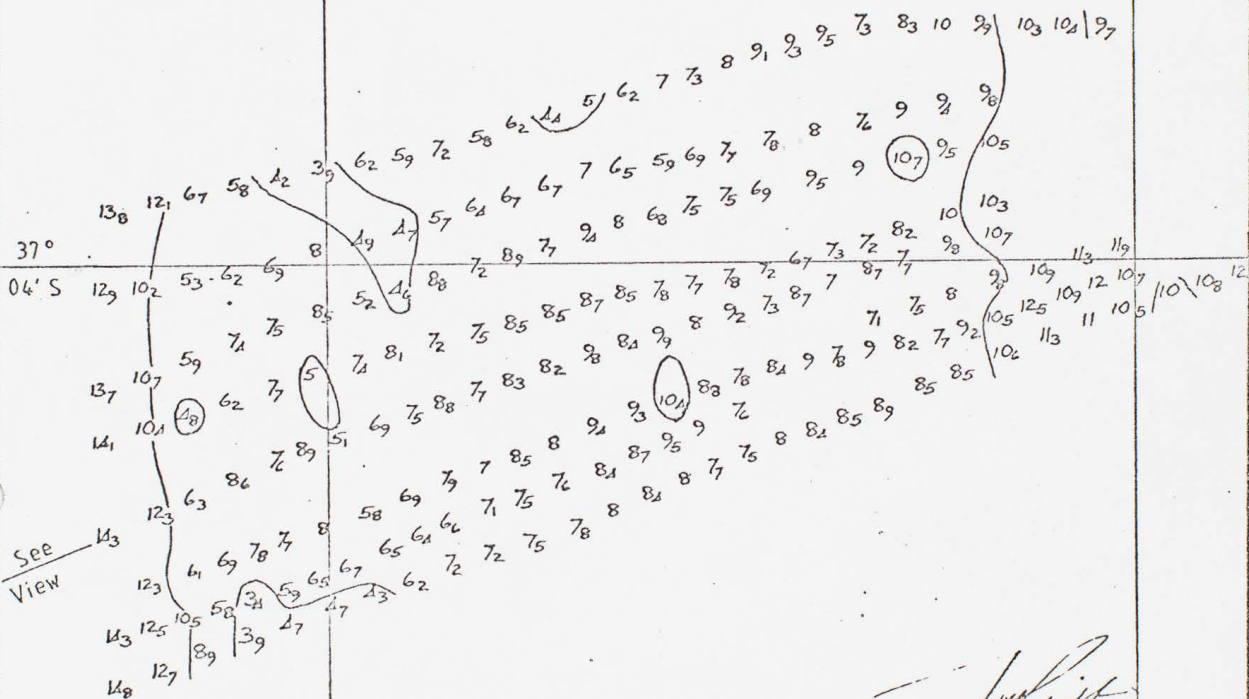
H5/1/46

MANUKAU HARBOUR ENTRANCE-WESTERN SHOALS

The shoal at the southern side of the channel has decreased by 1m to 3.4, otherwise depths in excess of 5m exist along the leading marks depicted on the plan.

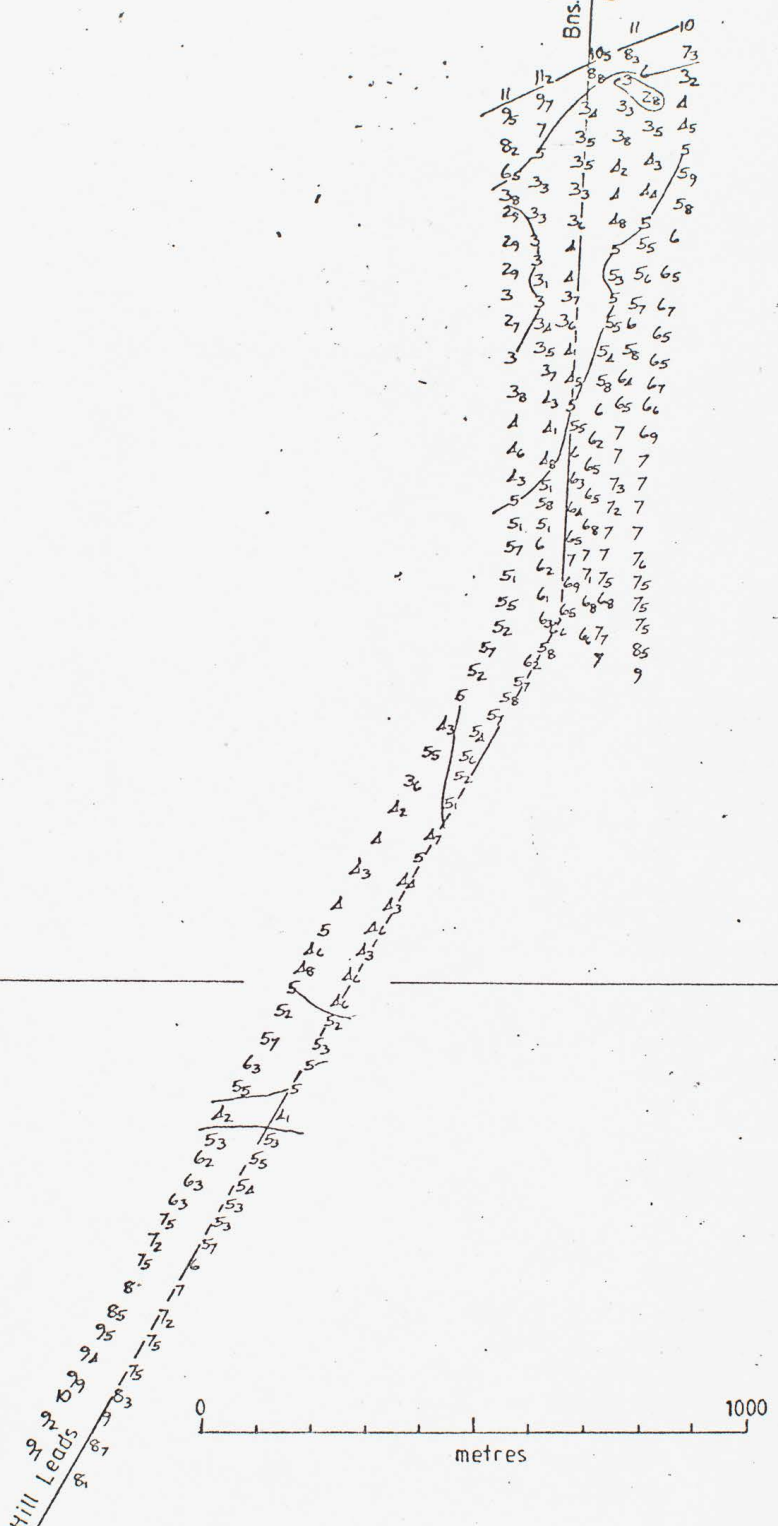
DRAWING  
 H5/1/45  
 Amendment 6

MANUKAU HARBOUR ENTRANCE-SOUTH CHANNEL  
 Surveyed 10 JAN 1984  
 Soundings in metres & decimetres below C.D.

This shows that the shoal of 3m or less previously straddling the line of the Gully leads has receded westward and the sandspit growing from the beach below the signal station has also extended westward to a point 70m east of the leads where a sounding of 3m was located in position 327° 1390m from the lighthouse. To the SW of this shoal the 3m contour of the bank 70m to the west of the leads lies in position 310° 1190m from the lighthouse. The best water is directly along both sets of leads where least depths found are as follows:-

- Hill leads 4.1m 242° 1550m from the lighthouse
- Gully leads 3.3m 319° 1270m from the lighthouse

The South Channel continues to show instability and should be used with caution. If sea conditions permit the approach across the Western Shoals will give 2m greater depth.

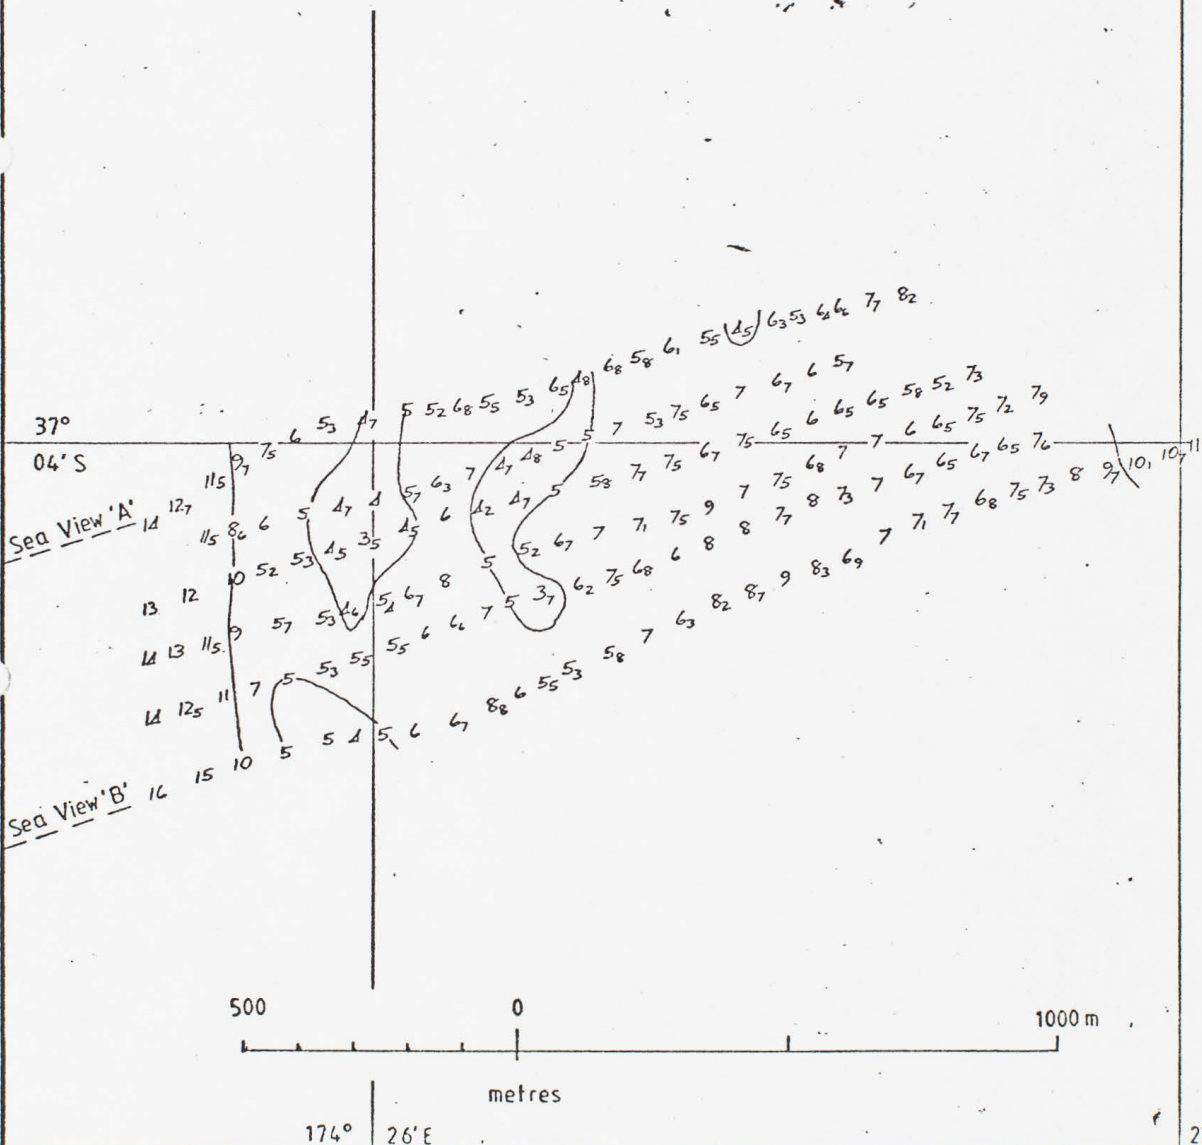
MANUKAU HARBOUR ENTRANCE-WESTERN SHOALS	DRAWN R/WB	DRAWING H5/1/46 Amendment 1
	Surveyed 18 Oct 1983	DATE 19 10 83	
	Soundings in metres & decimetres below C.D.	SCALE 1:12,000

Apart from the usual movement of the 10m contour, 150m to the west since the Navy Survey of March 1982, there appears to be little significant difference in depths with isolated shoals of from 3.5 to 5m which will fluctuate in both positions and depth with wind and tide.

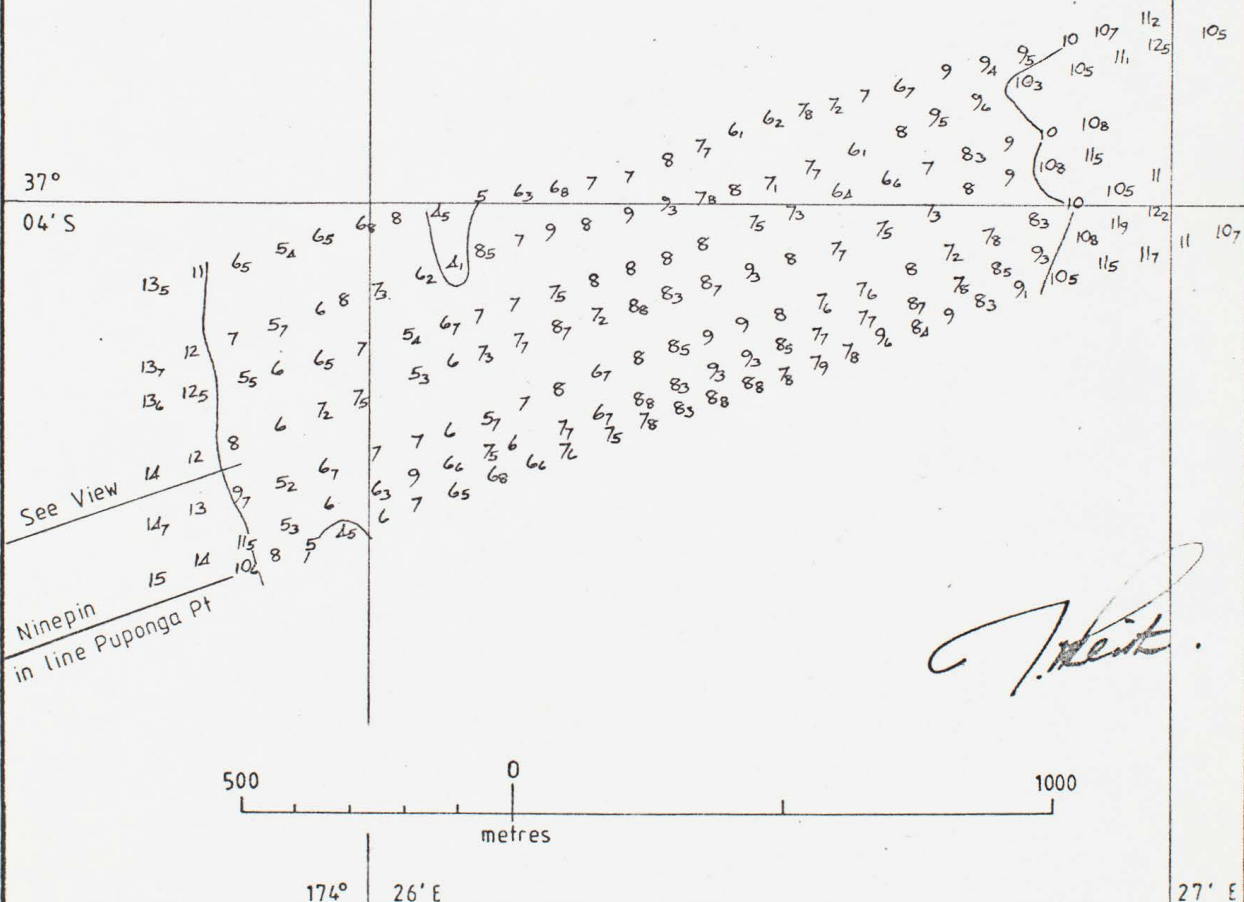
MANUKAU HARBOUR ENTRANCE-WESTERN SHOALS	DRAWN R W B	DRAWING H5 / 1 / 46 Amendment 2
	Surveyed 10 JAN 1984	DATE 11-1-84	
	Soundings in metres & decimetres below C.D.	SCALE 1:12,000

This approach is now being used by all but one of the larger ships regularly visiting Onehunga. Considerable improvement in depths since the last survey have established a channel of 300m in width with an easily definable lead as indicated on the resultant plan with depths in excess of 5 metres.

Comparison with the Navy 1982 survey shows that the ten metre contour has moved 200m to the west and that shoals of less than 5m have either migrated westward or disappeared.

As the Middle Deep is also extending westward it would appear probable that the cyclic variation here is coming back to the 1954 situation (see plan attached). In view of the present state of the South Channel I would recommend that the larger vessels continue to use this approach even if breakers are present in westerly weather conditions.

The best water is found by having Ninepin Rock half a width open to the south of the southern point of Paratutai Island.

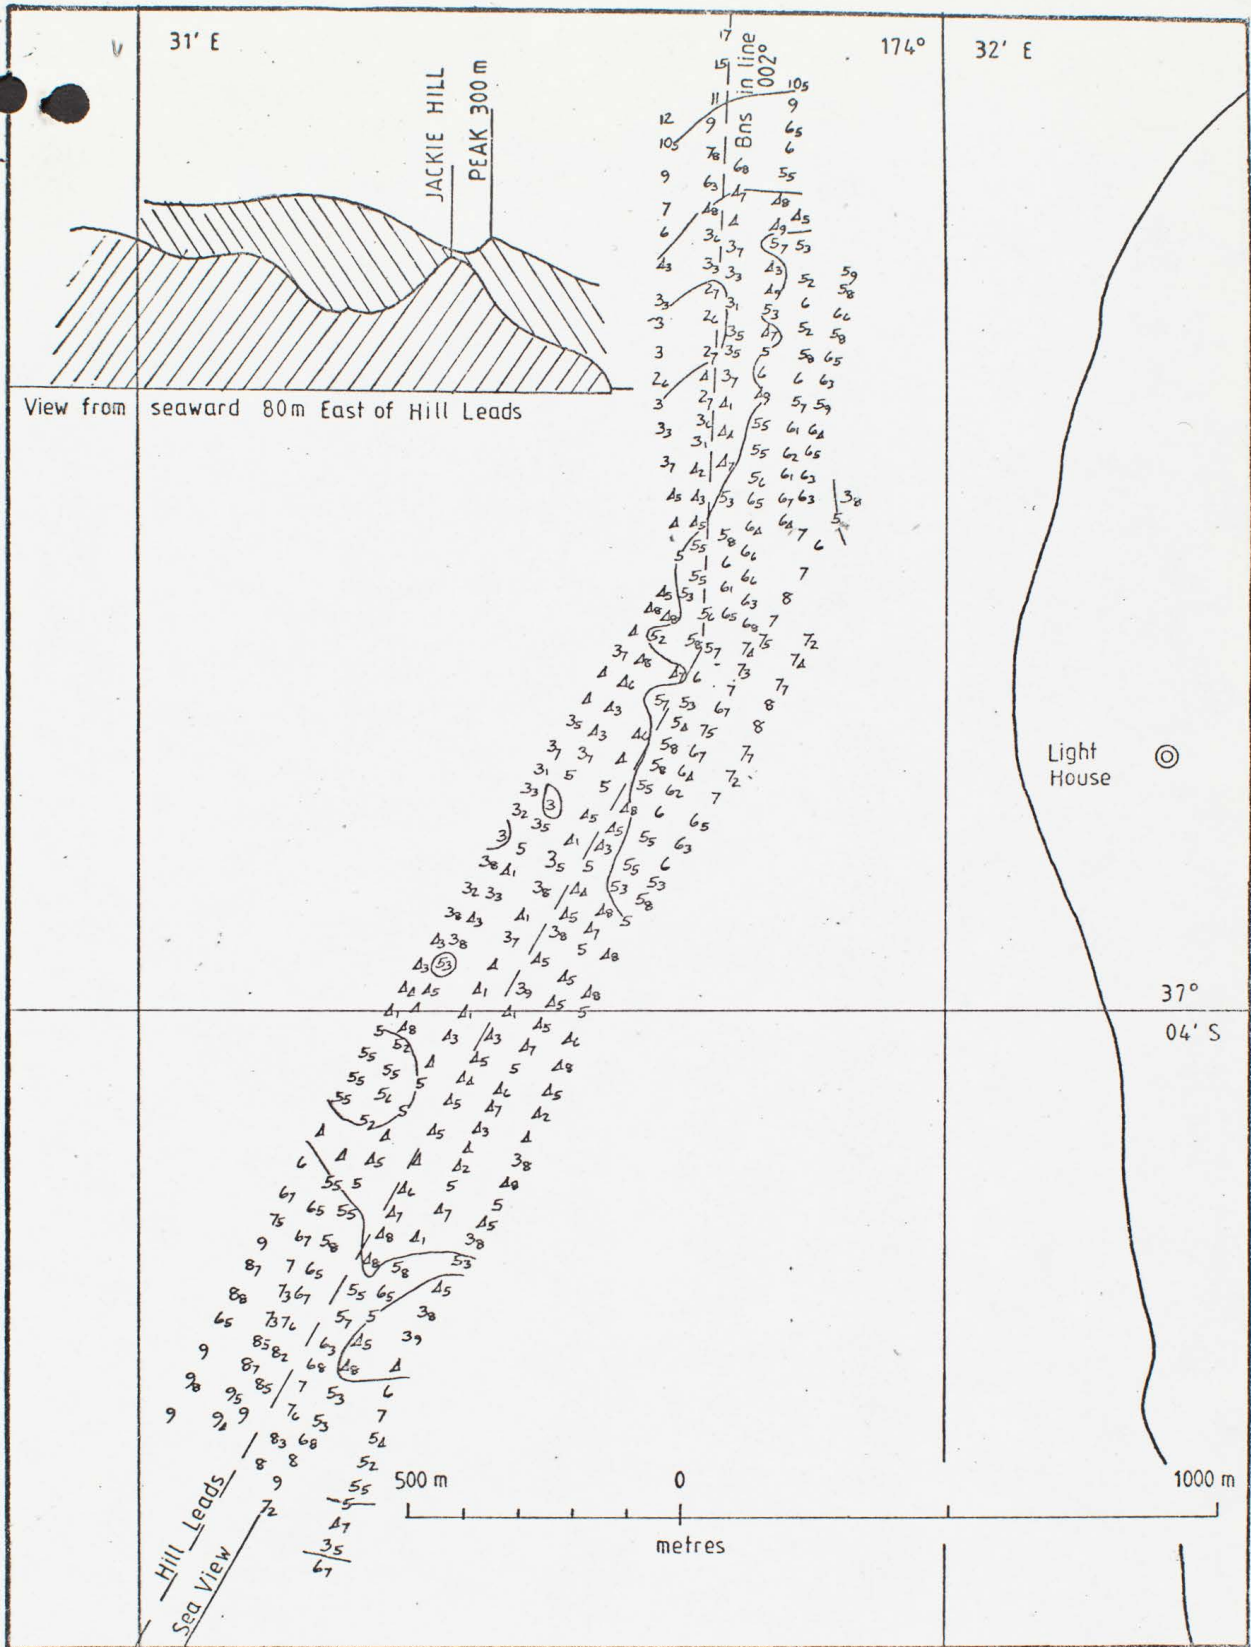
H5/1/45

The shoal lying across the northern end of the Destruction Gully leads has receded further to the west. On these leads the least depth was 2.6m 313° 1160m from the lighthouse. On the Hill leads the least depth is 3.8m 254° 1200m from the lighthouse.

The best approach was found to be 80m east of the Hill leads, then along the Gully leads with the northern beacon two widths open to the east of the south beacon.

These surveys confirm the findings reported by Tug "Manukau" upon which ships are being directed. It is recommended that reconnaissance by the tug should continue as these have proved invaluable in finding the best water.

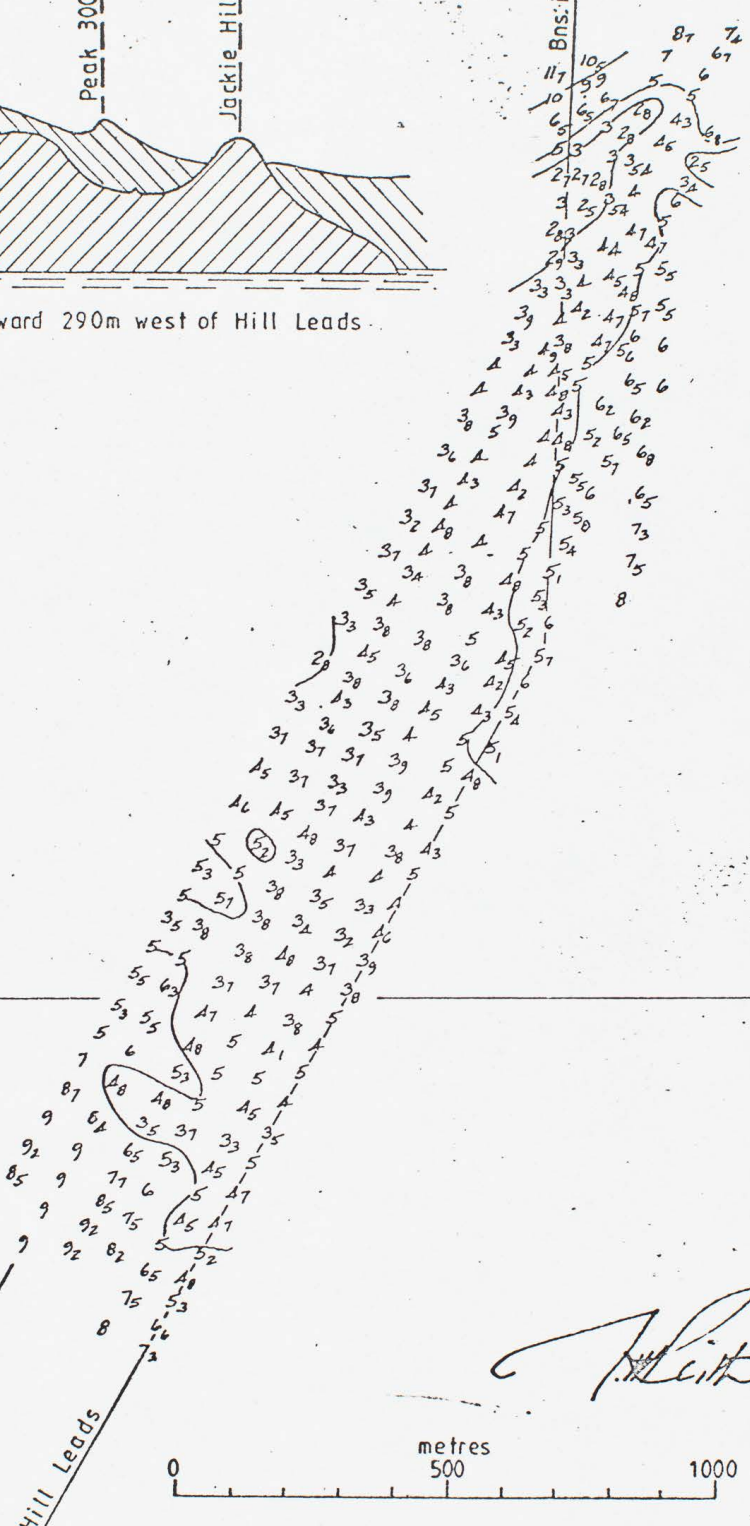
H5/1/45

MANUKAU HARBOUR ENTRANCE-SOUTH CHANNEL

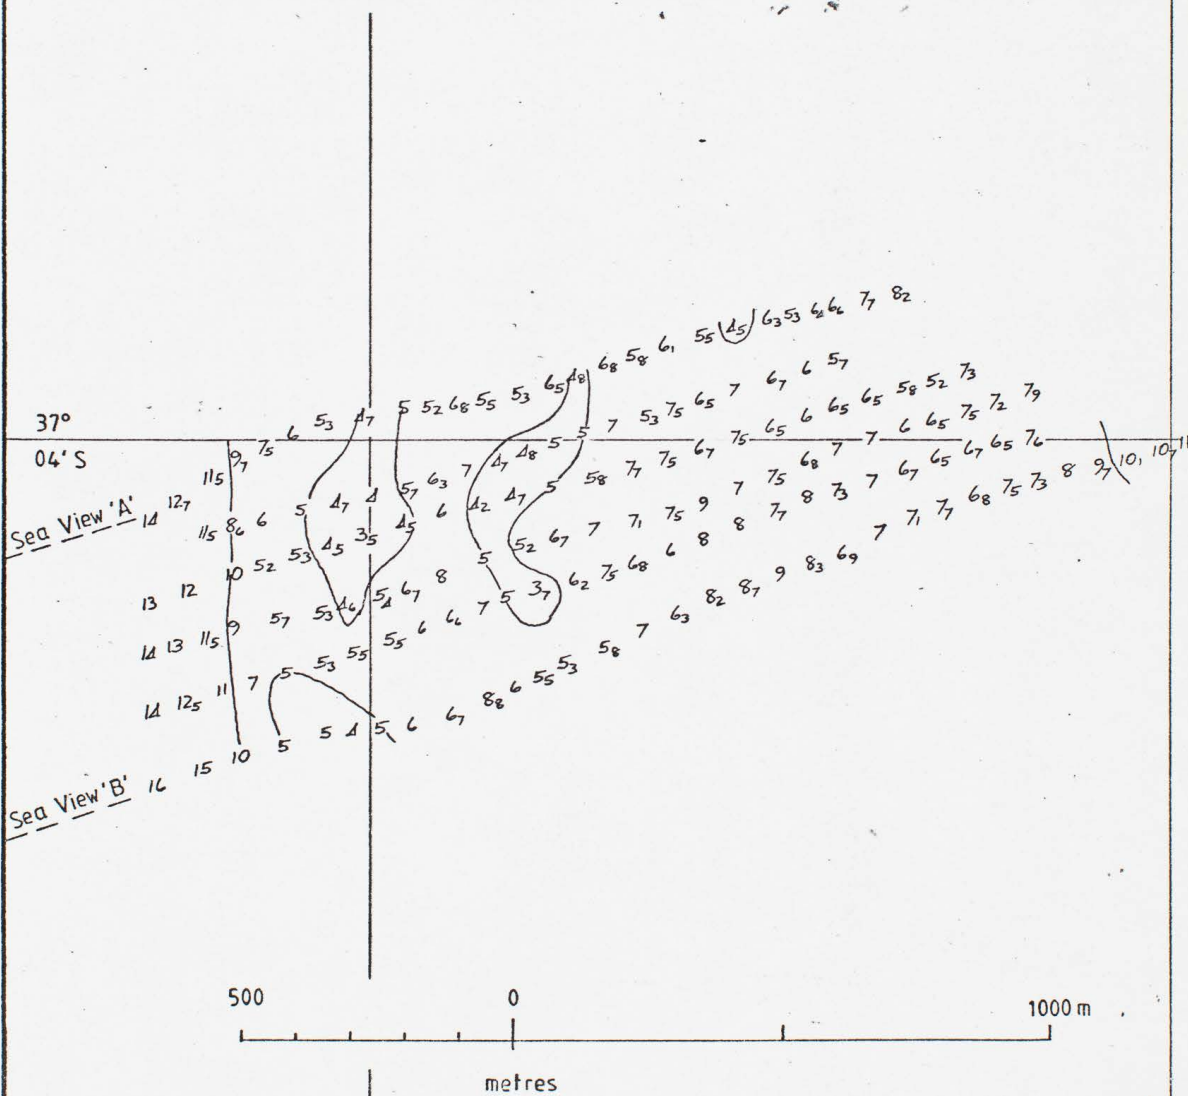
DRAWING  
 H5/1/46  
 Amendment 1

The area sounded was clear of breakers but probably would be breaking with less tide.

MANUKAU HARBOUR ENTRANCE-WESTERN SHOALS  
 Surveyed 18 Oct 1983  
 Soundings in metres & decimetres below C.D.
