Ferry Buildings

Gurley & Nicholls

Correspondence from
Nov 1979

FERRY BUILDINGS - REQUEST BY CONSULTANTS
FOR PERMISSION TO PRESENT A PAPER

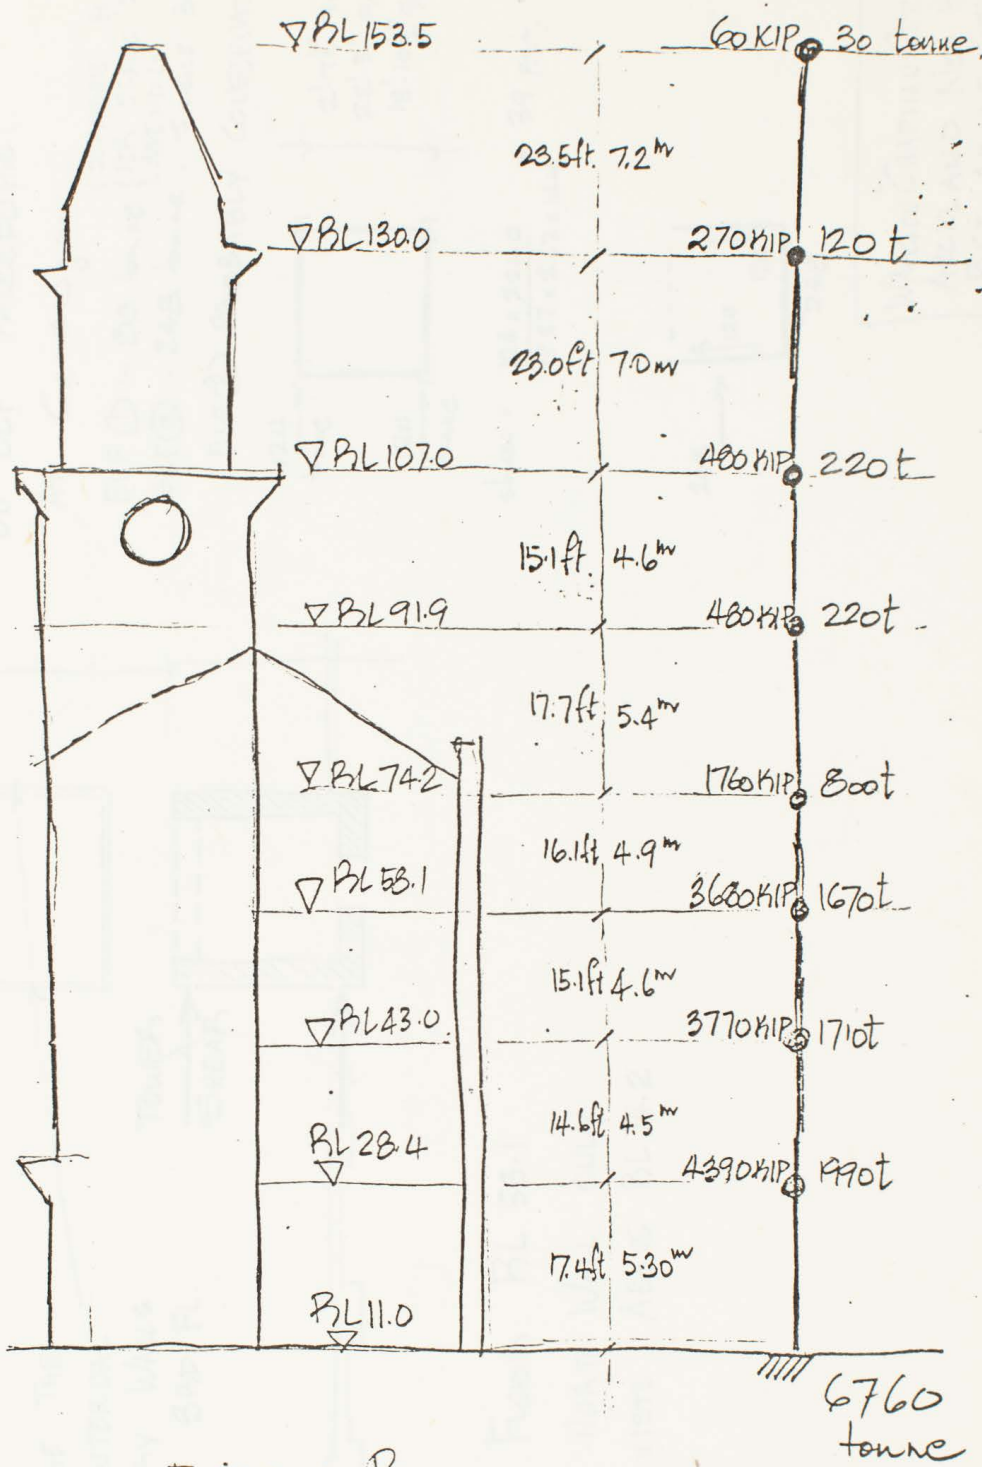
FERRY BLDG.
DEAD LOAD SUMMARY.

WARCIAN CHAPMAN GURLE
AUCKLAND NOV 1974
REF AK135/SK4

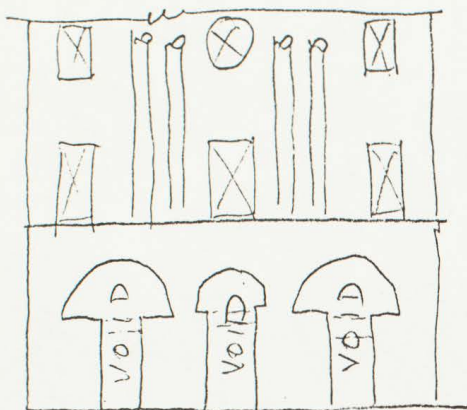
PART WEST ELEVATION

$$\begin{array}{r} 75 \text{ m} \\ 68 \text{ m} \\ 18 \text{ m} \\ \hline 161 \text{ m} \times 2 = 322 \text{ m} \end{array}$$

At 5 psi	SHEAR = 102 tonne = 0.0151g
10 psi	= 204 tonne = 0.030g
15 psi	= 306 tonne = 0.045g

SHEAR STRENGTH ALLOW 18 ft² EFFECTIVE

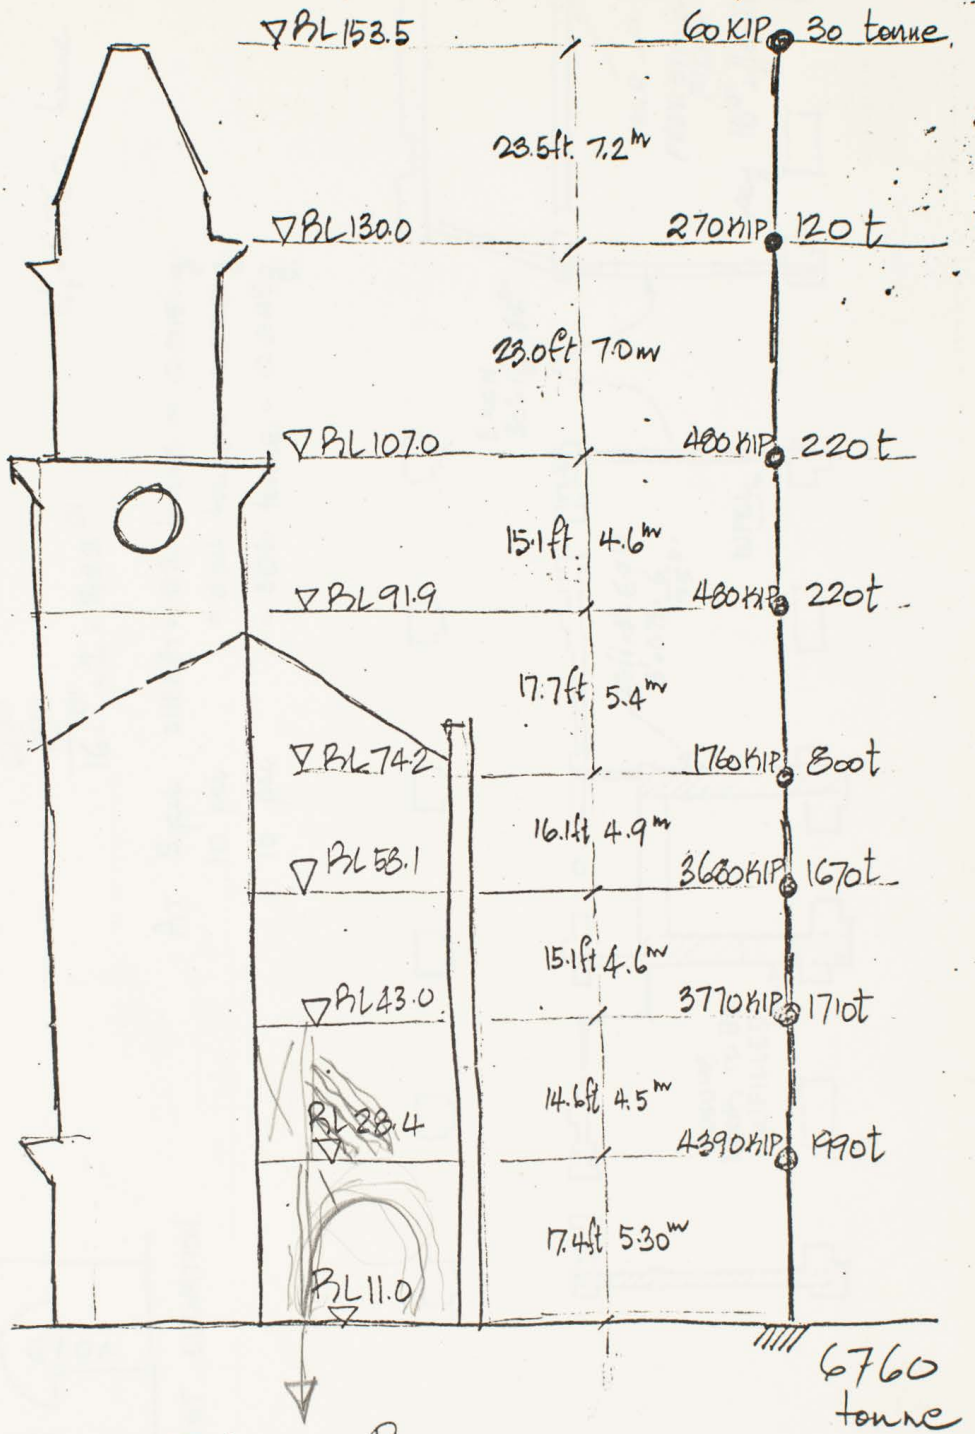
FERRY BLDG.
DEAD LOAD SUMMARY.

WARGON CHAPMAN GURLEY
AUCKLAND NOV 1979
REF AK135/SK4

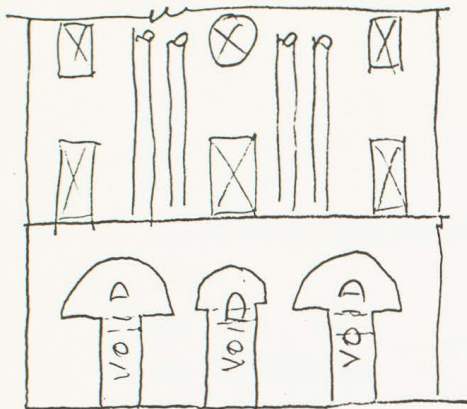
PART WEST ELEVATION

FERRY BUILDING
 GROUND FLOOR PLAN
 N-S SHEAR AREAS

At 5 psi	SHEAR = 102 tonne = 0.0151g
10 psi	= 204 tonne = 0.030g
15 psi	= 306 tonne = 0.045g

SHEAR
 STRENGTH
 ALLOW 18 ft²
 EFFECTIVE
