1000 Manukau Harb.
General.

Manukau Harbour gen.

incl Survey of Harbour Entrance
- Wairopa channel.

REPORT OF SURVEY - PURAKAU CHANNEL

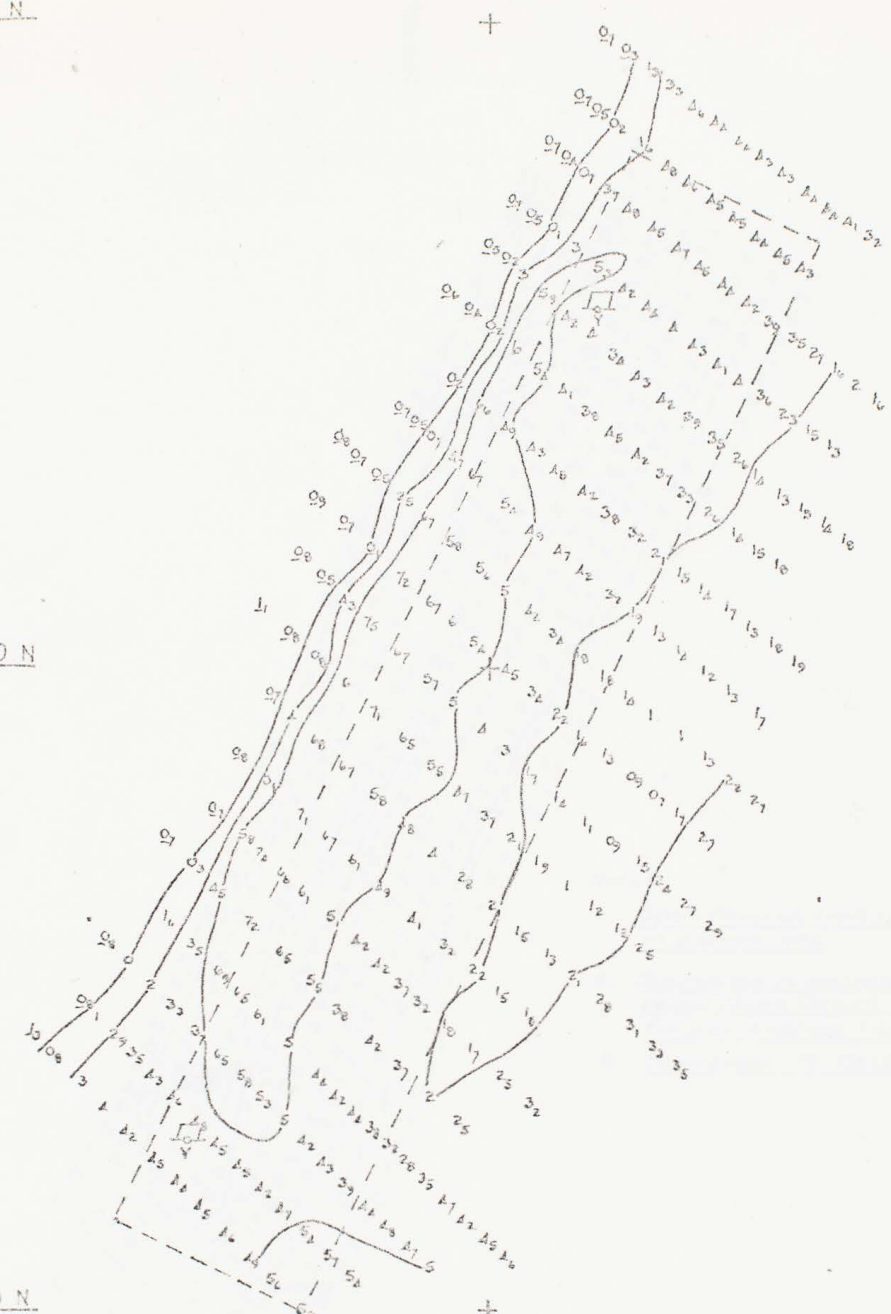
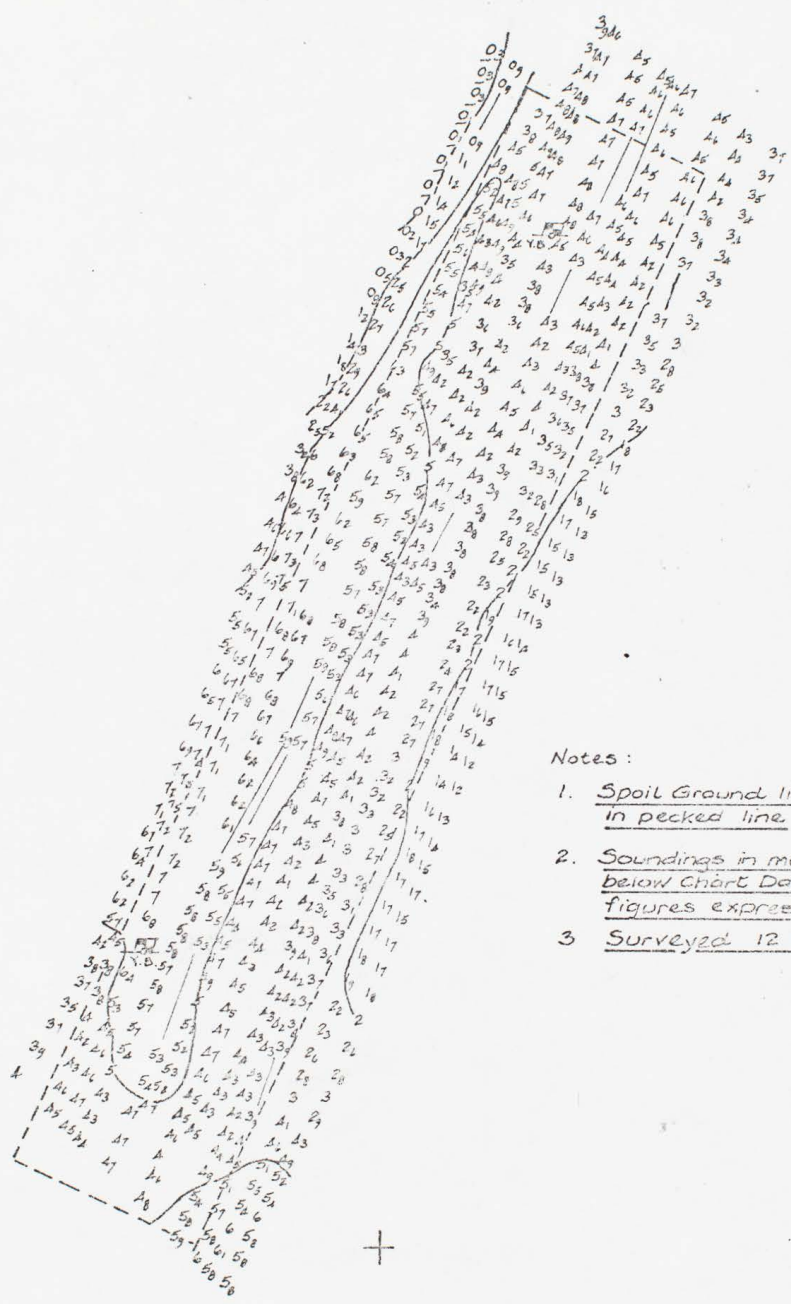
Apart from the change in position and colour of the buoys little change in depths is apparent and little or no dumping has taken place in the past year.

In the 1981 survey lines of sounding were run longitudinally along the channel because of the draught and lack of manoeuvrability of Tug "Manukau" as on the western side of the channel Te Tau Bank rises very steeply.

The recent survey was carried out in "Arahi" with the sounding lines running correctly across the channel to give more accurate cross sectional profiles.

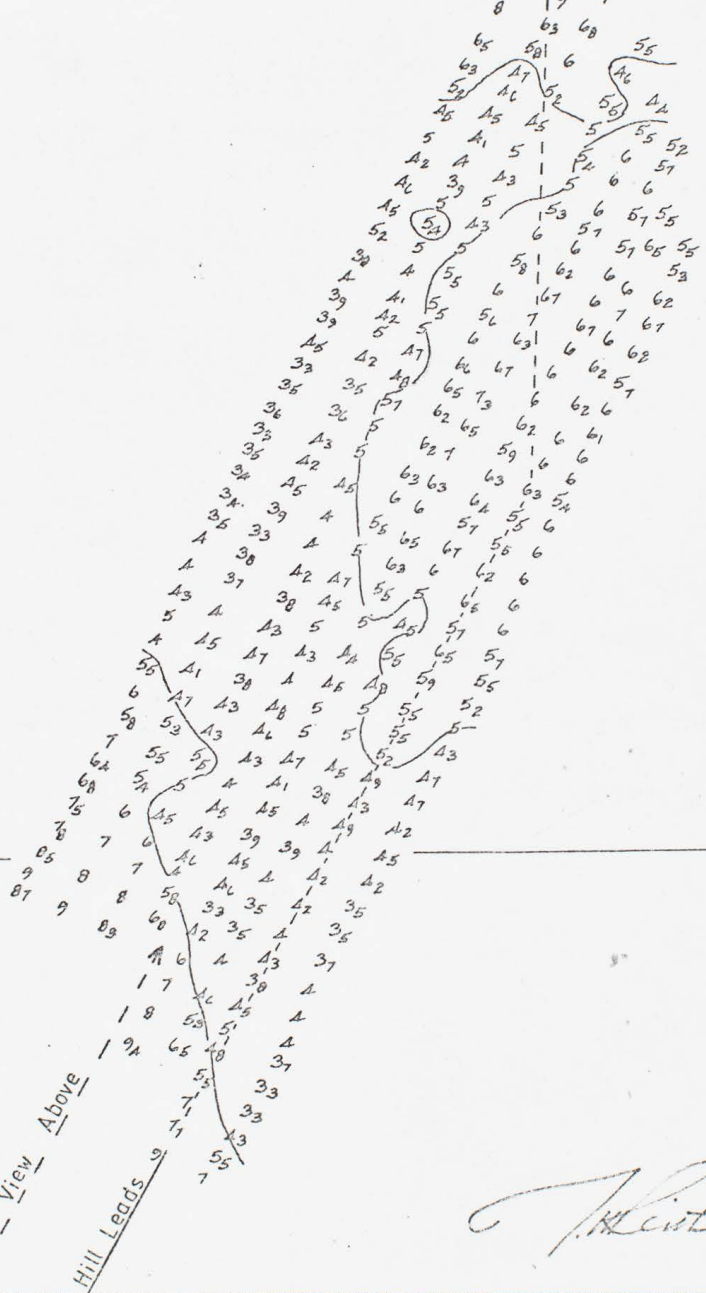
DRAWING
H5/1S/44
Amendment No. 7

It is evident that the long period of strong westerlies that have prevailed over the past three months have caused a migration of sand now deposited on the shoal lying athwart the channel on the Hill leads to the west of the lighthouse. In general this shoal is in the same position as found in surveys since July 1980, major changes are as follows:-

1. A drying sandspit has appeared at the northern end of the channel to the east of Destruction Gully leads line.
2. Shoals with depths of less than 3 metres were found in the following positions:- (Bearings and distances from the lighthouse)
 - (a) Depth 2.1 metres 272° 1400 m.
 - (b) " 3.0 " 253° 1350 m.
 - (c) " 2.5 " 242° 1700 m.

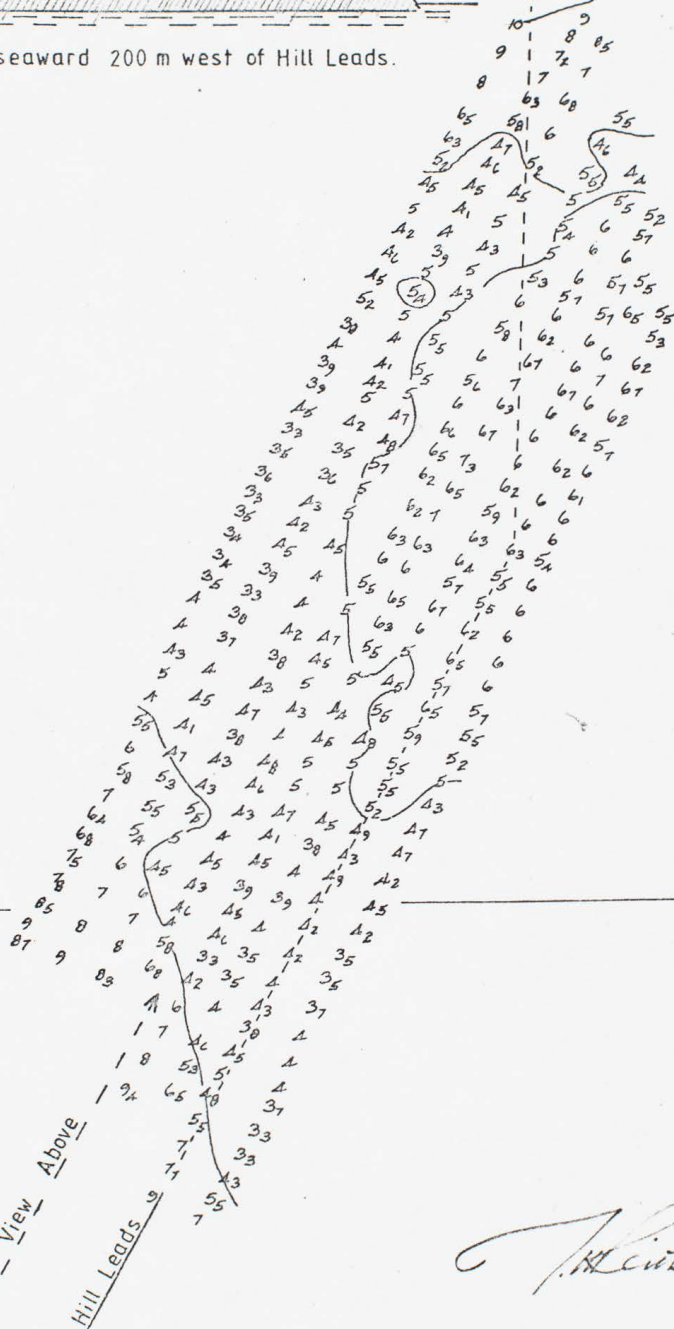
DRAWING
H5/18/44
Amendment No 5

1. The Sandspit at the northern end of the channel on Destruction Gully leads has become re-established with depths averaging 4.5 metres.
2. The shoal lying athwart the channel on the Hill leads is still in the same position as found in the last two surveys, i.e. since July 1980.
3. The best approach would now appear to be on the Hill leads where a least depth of 3.8 metres exists in position 242½°, 1,550 metres from the Lighthouse. Good water also can be found on the previously recommended approach 200 m west of the Hill leads. (See Sketch of view from seaward on plan.)

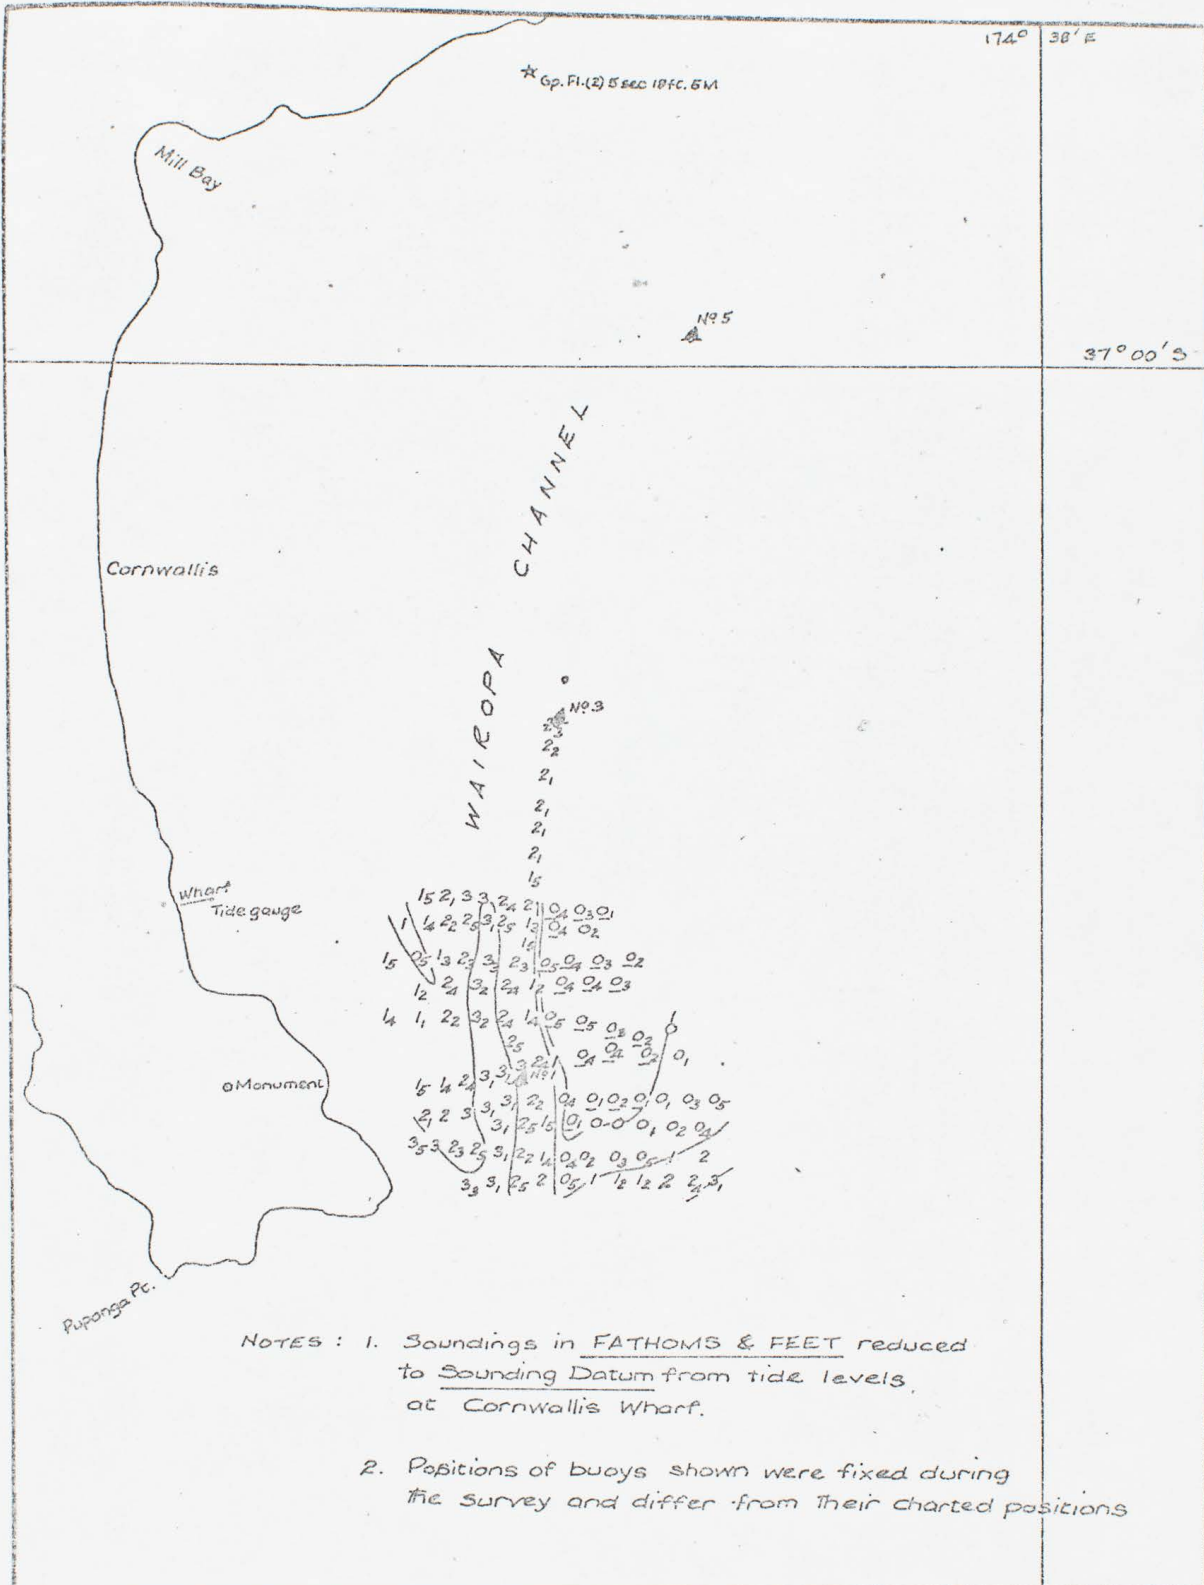
The attached plan H5/30 shows the results of the survey (in Fathoms and feet) and it is clear that the southern point of Te Tau Bank has extended to the south by about 400 metres since the R.N.Z.N. survey in 1961. As a consequence of this vessels entering Wairopa Channel from the S.E. after anchoring in Big Bay and making to round No. 1 buoy are being led into shoal water. It is therefore recommended that No. 1 buoy be moved to a position 110° , 850 metres from the Memorial on Puponga Point, approximately 183° , 420 metres from its present charted position. As a precautionary measure a marker buoy was laid in this position and, taking the track of a vessel entering from Big Bay anchorage, a line of soundings was run from this point in a direct line to No. 3 buoy, this giving a least depth of ⁴²11 feet.

No. 1 buoy is 170 m south of its charted position and consideration was given to dragging it further south to the recommended position above, but the buoy has not been changed since October 1977 and the risk of parting the chain was considered too great.

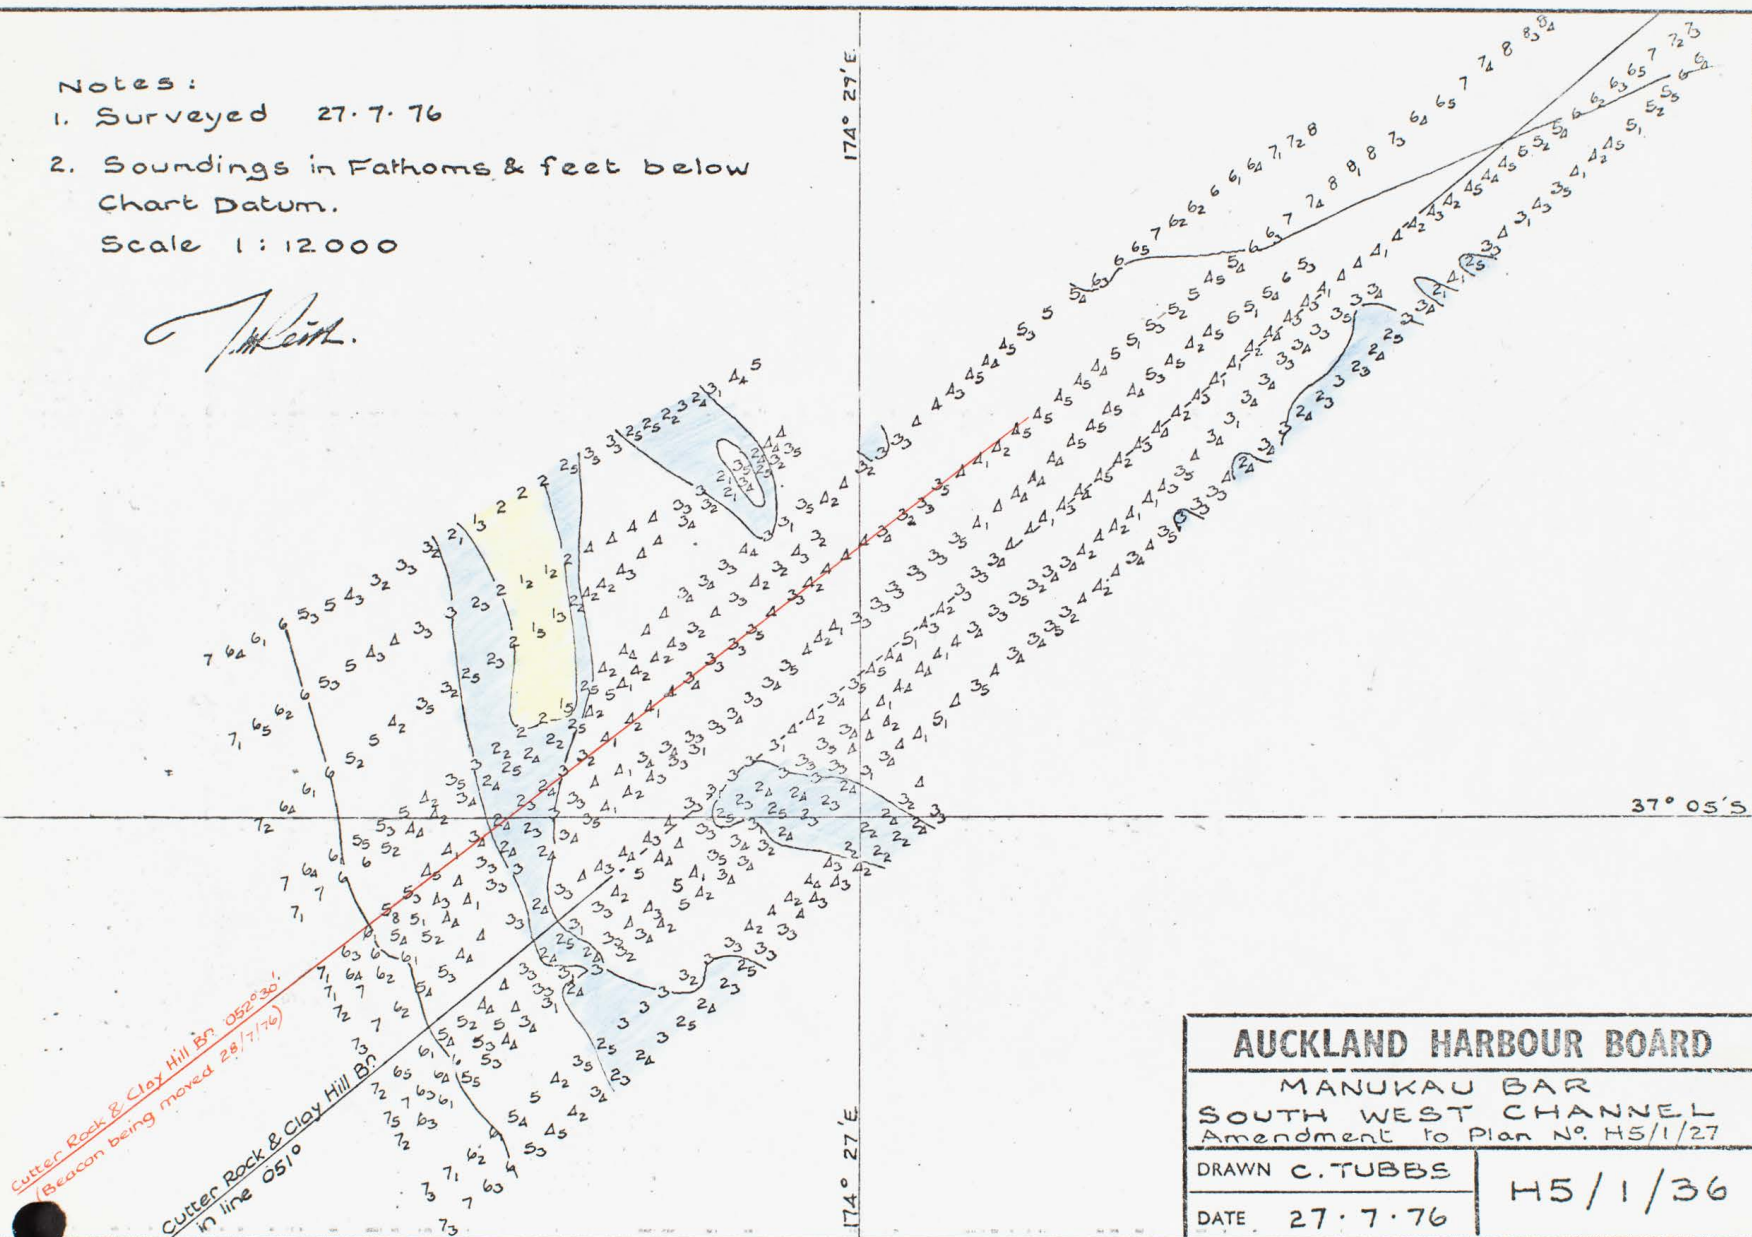
MANUKAU BAR
SOUTH WEST CHANNEL
Amendment to Plan No. H5/1/27

In good sea conditions and at High Water a comprehensive survey was carried out in the South West channel to both North and South of the Cutter Rock $052\frac{1}{2}^{\circ}$ Leads and embracing an area of some 1.5 by 0.5 sea miles.

Vessels crossing the Bar on this Lead should find a minimum depth of 15 feet over a distance of 600 feet to the north and southward. In the close proximity of the Leads a least depth of 16 feet will be found.

It was observed during this survey that the Hook of the South Bank has grown to the westward in recent months.

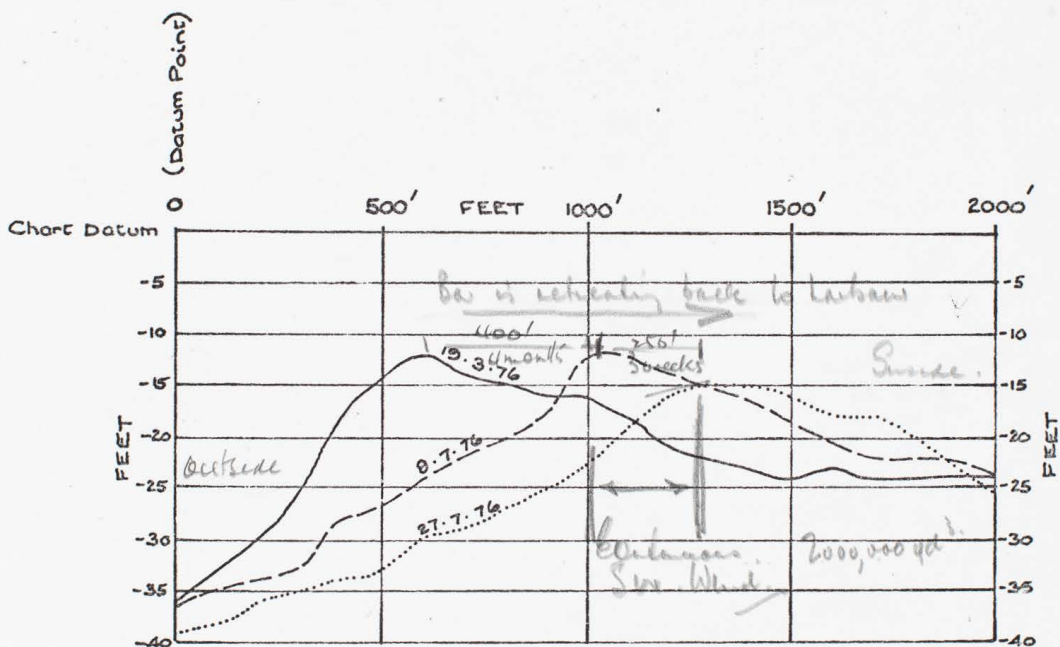
AUCKLAND HARBOUR BOARD	
MANUKAU ENTRANCE REPORT OF SURVEY APPENDIX	
DRAWN <i>G.H. Cook</i>	
DATE 28.7.76

CROSS SECTION SHOWING SEABED LEVELS
OBTAINED DURING PERIOD 19.3.76 to 27.7.76

CROSS SECTION ALONG CUTTER ROCK & CLAY HILL BN
TRANSIT (052°30') WITH DATUM POINT IN POSITION
232½°, 23,000 FEET FROM CUTTER ROCK.

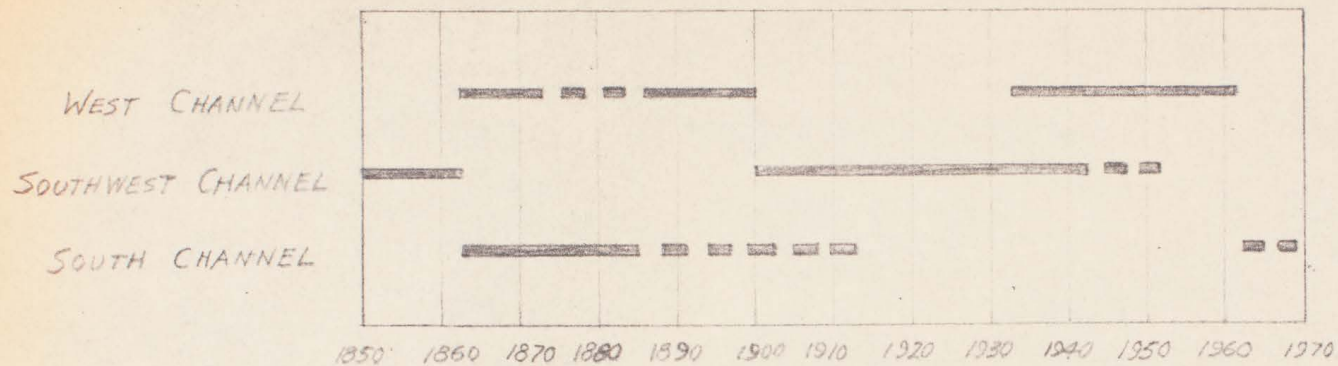
AUCKLAND HARBOUR BOARD	
MANUKAU HARBOUR ENTRANCE	
PERIODS OF OPEN CHANNELS	
DRAWN <i>R.M.</i>	51612/1
DATE 25-2-63

Dates have been obtained from old charts and
 Advice to Mariners and are not to be considered
 completely reliable.
